Habitat Restoration Project 2006

- Cobourg Brook -

Nelson Property Low Level Stream Crossing and Planting

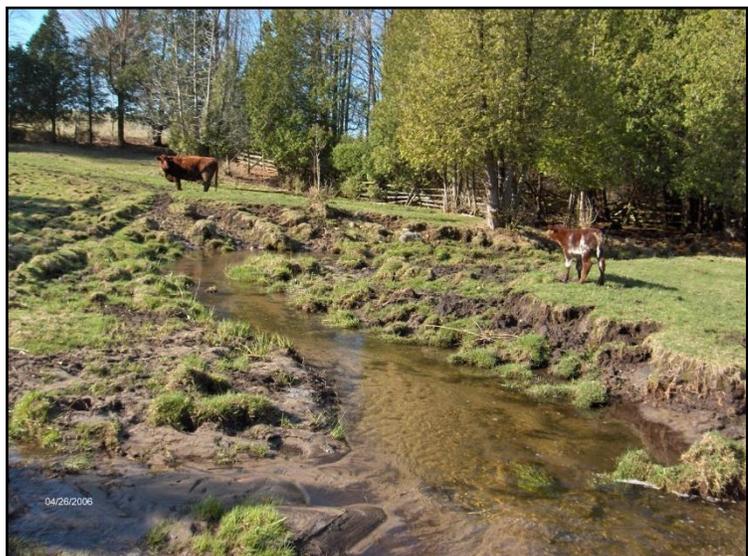
The Nelson property along the Cobourg Brook is a cattle farm, with an area through the stream that is severely degraded by cattle and equipment crossing (see figure 1). The Ontario Federation of Anglers and Hunters suggested pre restoration monitoring including OSAP, OBBN and fish sampling. The cattle were then fenced out of the creek, and the goal was to provide a single stable crossing point for both cattle and farm equipment. Fencing the cattle out aimed to prevent further degradation of the stream channel, allowing the banks to stabilize and re-vegetate and allowing the flow to be unrestricted, therefore allowing for the flow to scour the sediment and expose the substrate needed for productive fish habitat. Water quality will also continue to increase as the system flushes itself out. Restoration efforts included the grades on both sides of the stream being brought back to original slope levels,

Figure 1: Baltimore Creek before bed-level crossing constructed

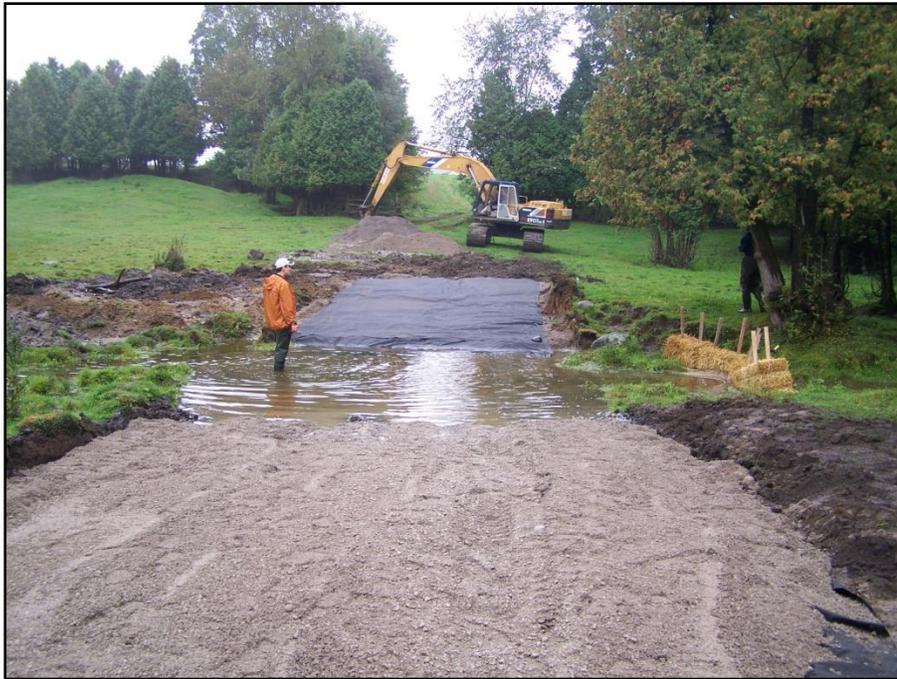
Figure 2: Laying Sand, geotextile and silt fencing down while re-creating stream crossing.

the creek bed excavated to a depth of 20'', a layer of sand placed along the approaches, a geotextile laid on top of this sand and across the creek, gravel laid on top of the geotextile and tamped into place, 10'' to 20'' of stone laid down to bring the stream bed up to the existing grade prior to excavation and finally planting on both sides of the creek within the fenced off areas (figure 2). The post restoration monitoring of the area showed immense improvement to the site in 2007 and 2010, shown in figure 3.

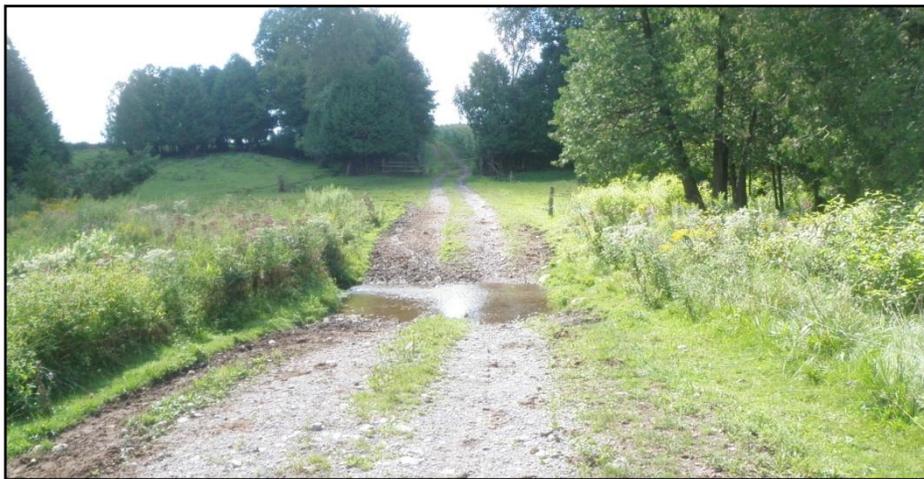
Figure 3: Baltimore Creek after bed-level crossing construction, 2010.
