Habitat Restoration Project 2007
- Cobourg Brook: Cobourg, Ontario -

Els Property Bank Stabilization

Habitat Project Lead: *Ontario Federation of Anglers and Hunters (OFAH)*

Date Completed: *August- September 15, 2007*

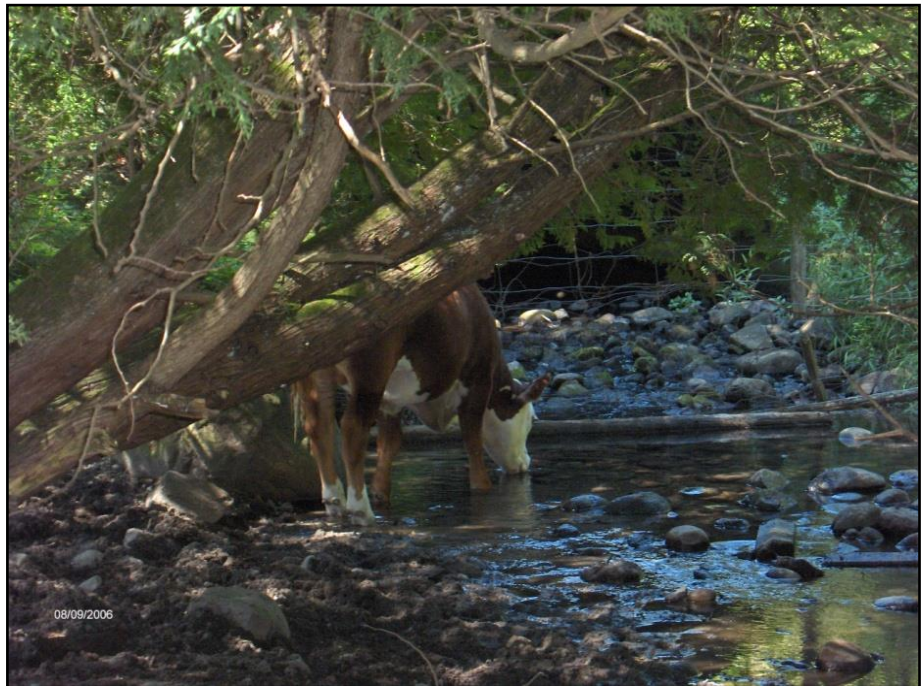
Figure 1: Cattle drinking from the stream on the Els property prior to contractor work.

The Els property is located on the Oak Ridges Moraine and has a small section of the East Branch of Cobourg Brook flowing through it. The landowner currently uses the property solely for grazing cattle on during the summer (figure 1). An earlier site visit determined that an alternate watering project was unfeasible for this site; however, there were some bank stabilization concerns. The cattle have degraded the banks and their presence contributed to increased sediment levels (figure 2). A local heavy equipment contractor was hired to re-grade the banks. Once this was completed, synthetic filter cloth was laid over the site and it was then backfilled with washed river stones and gravel, which aided in securing the river stone. One OFAH staff and two contractors completed the project, taking 5 hours and covered an area of 320m². The bank were stabilized after the contractor work was completed which increased the water quality and quantity at the site.

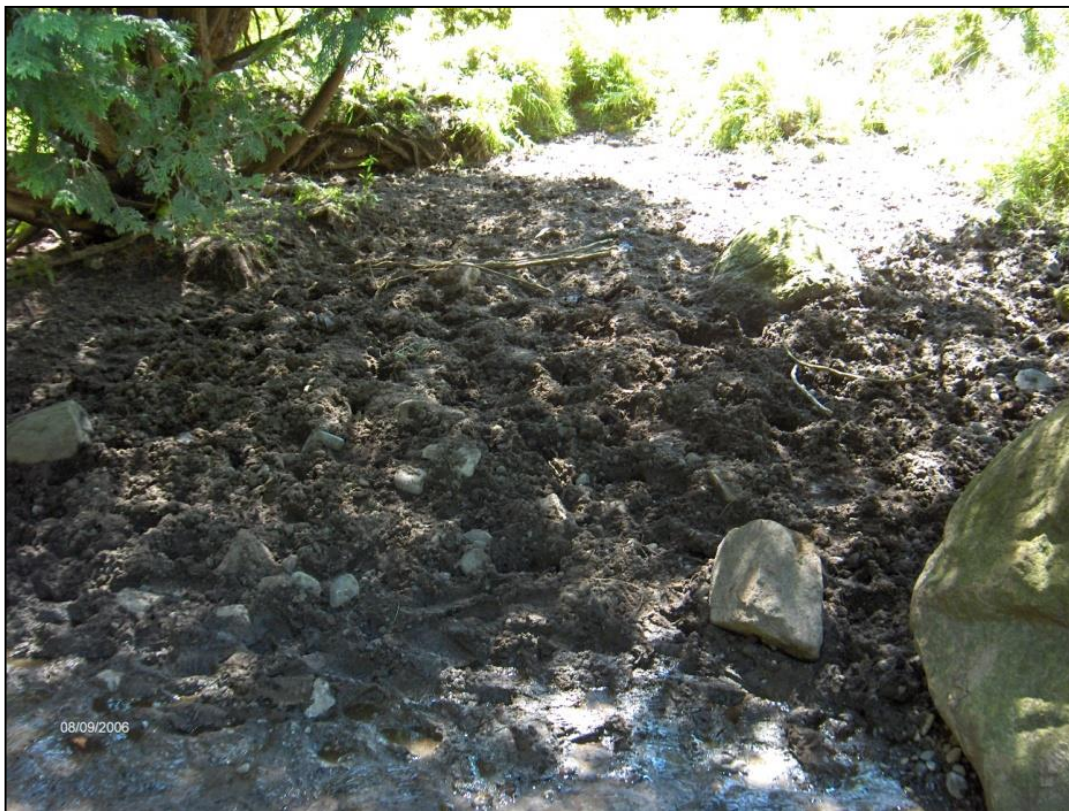
Figure 2: Clear bank degradation from cattle trampling and access into stream.
