Habitat Restoration Project 2008

- Duffins Creek: Ajax, Ontario -

Greenwood Conservation Area Bank Stabilization Project

Date Completed: *August-September 15, 2008*

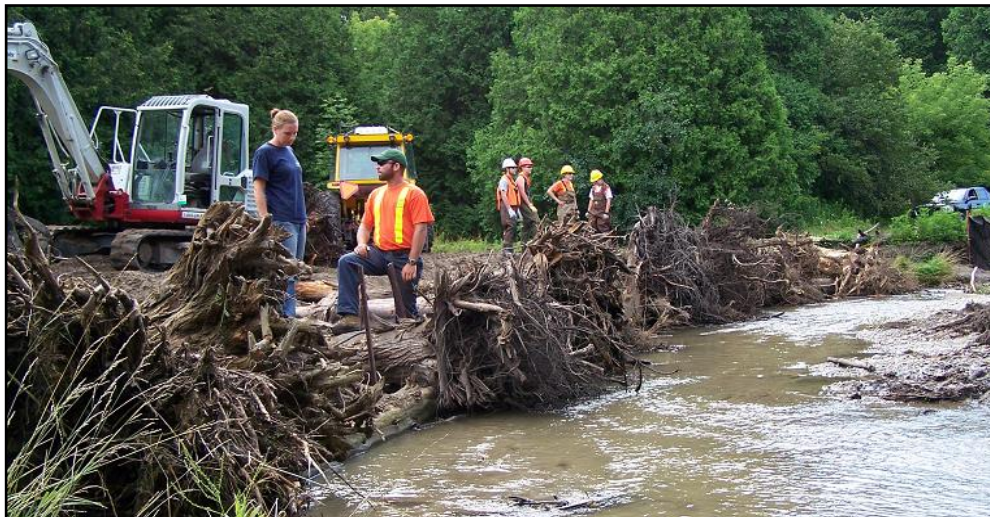
Figure 1: Root wads and woody debris being placed along stream bank to stabilize the shoreline.

Community members were using this site as an unregulated dog swimming area. It was primarily this activity that had severely eroded the bank and caused excess sediment to enter the creek, which is known to impede aquatic life. By affecting the integrity of the bank, downstream sections were being compromised, which was evident during the spring freshet. The bank was also continuing to washout because it was devoid of riparian vegetation. Visits to the site by TRCA staff determined that using large root wads and woody debris would be the best course of action for the creek and its inhabitants (figure 1). The direct benefits of the Greenwood bank stabilization project would be to reduce the amount of sediment entering the creek, improve in-stream and riparian habitat, and enhance/increase the riparian cover. This project involved the completion of a 40m long root wad bank creation over the course of five full days. It required the use of heavy equipment and field crews from the TRCA, OFAH and Aurora District MNRF. The riparian area directly behind the newly constructed bank was planted in the summer with 150 potted willow shrubs to further stabilize the bank (figures 2 & 3).

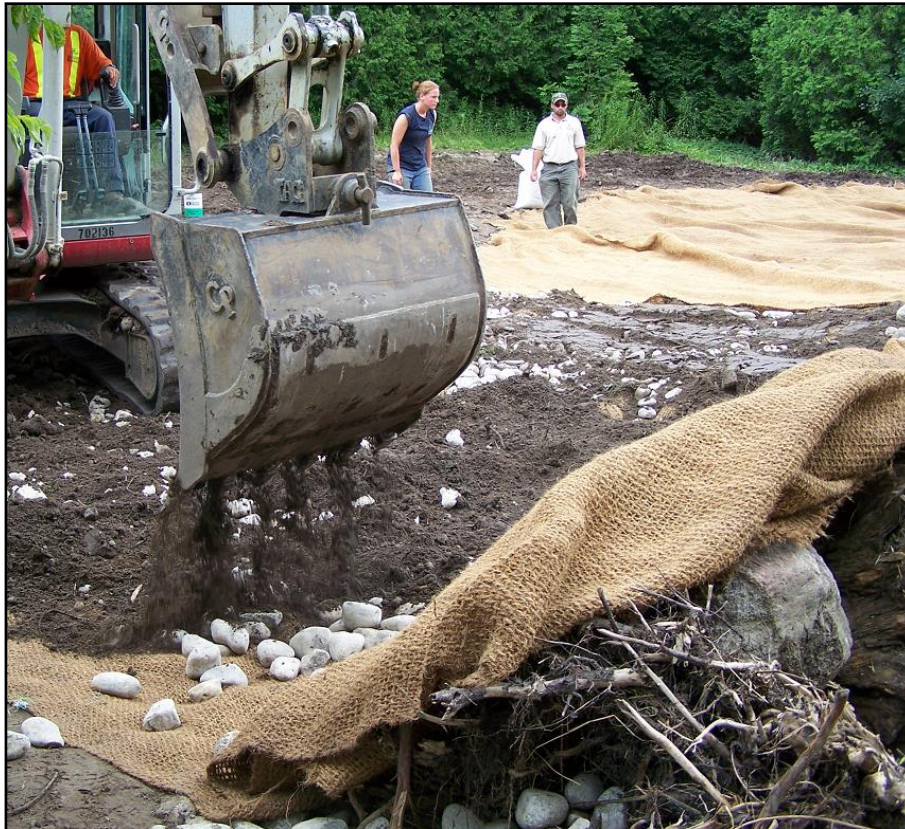
Figure 2: Core material was laid down and folded, additional localized soil and river stone were placed on top.

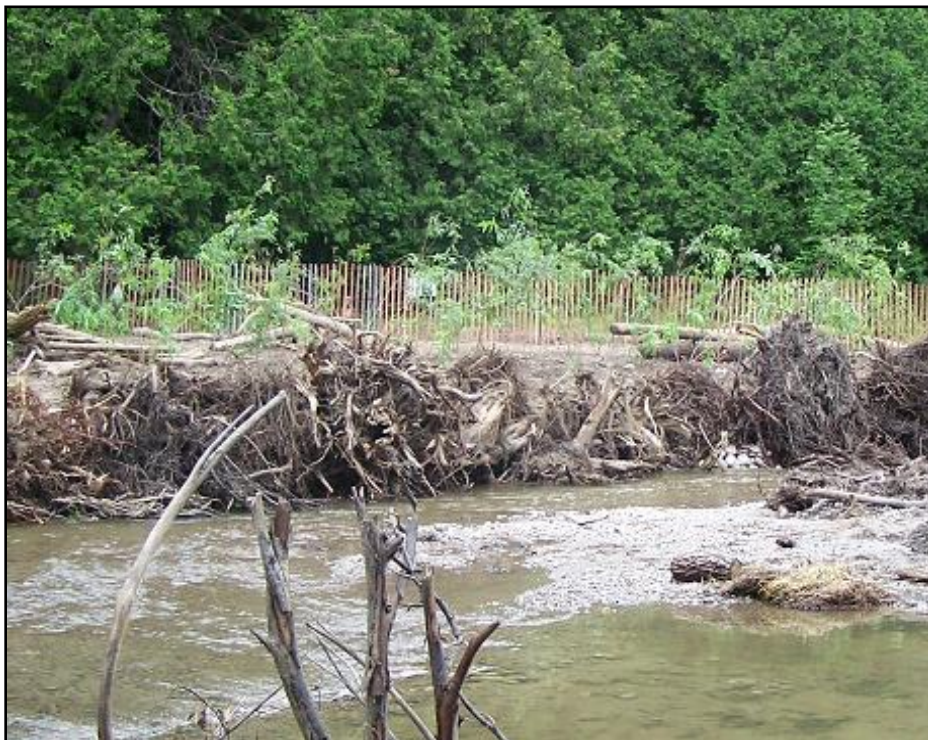
Figure 3: Completed bank stabilization project at Greenwood Conservation Area.
