Habitat Restoration Project 2008

- Cobourg Brook: Cobourg, Ontario -

Holmes/Town of Cobourg Property Bank Stabilization Project

Date Completed: *November 15, 2008*

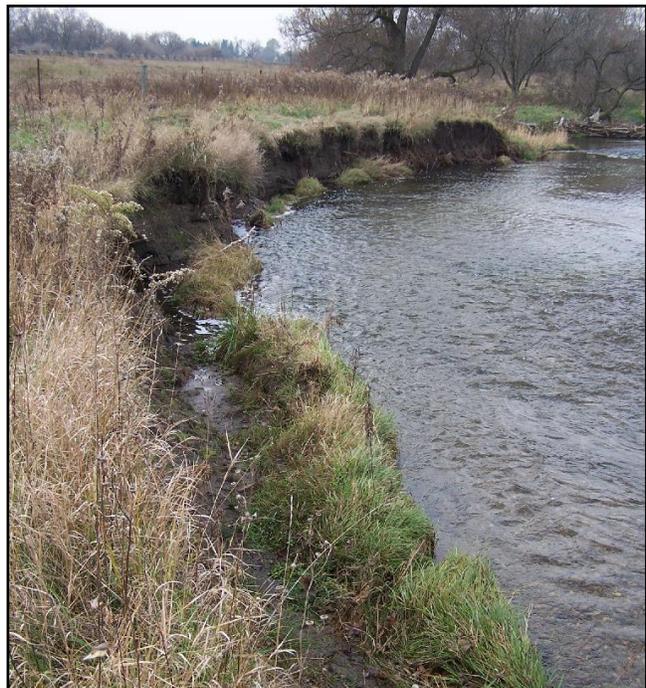
Figure 1: Bank severely eroded on Holmes/Town of Cobourg Property.

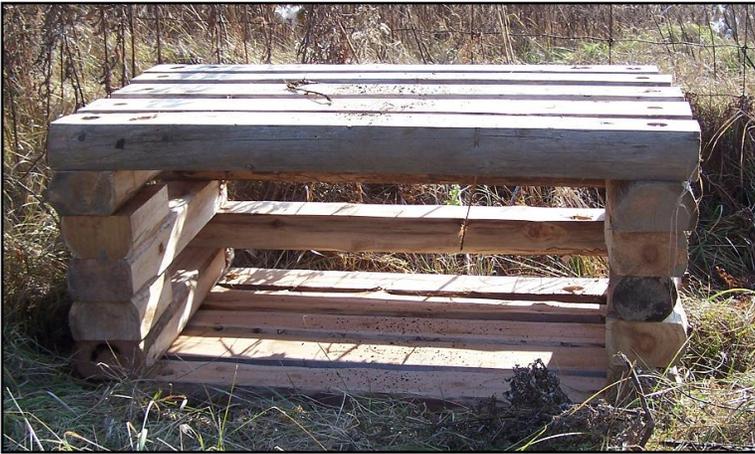
Figure 2: LUNKERS placed in stream to create habitat for Atlantic salmon and other coldwater fish species in Cobourg Brook.

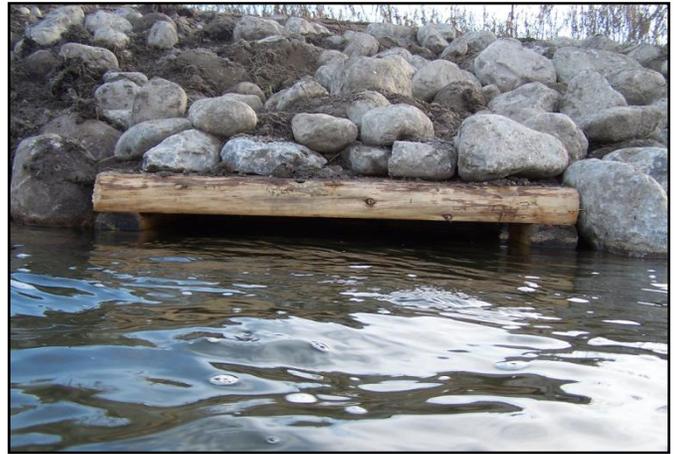
Figure 3: LUNKERS with boulders holding it in place in Cobourg Brook.

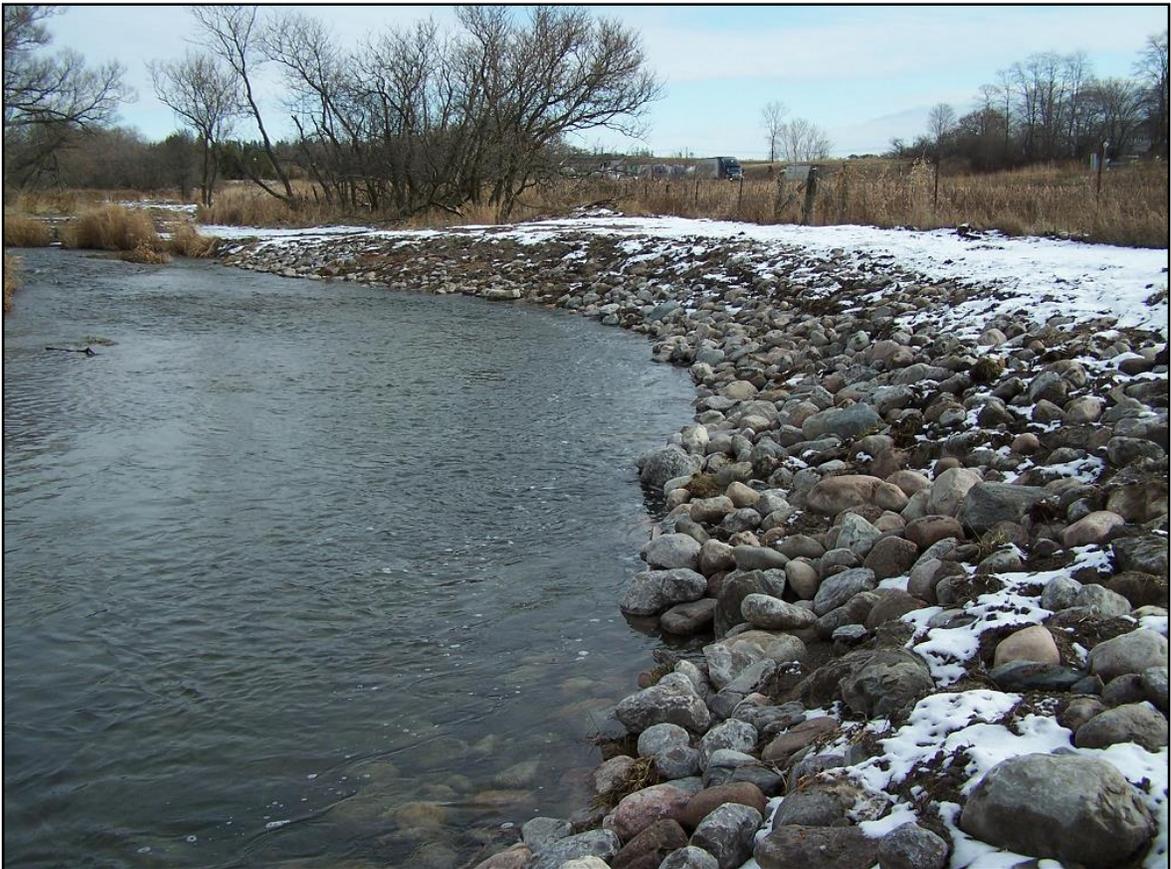
Figure 4: Holmes/Town of Cobourg Property Bank Stabilization project complete.

The location of the bank stabilization project is partially on Town of Cobourg land and the remainder is on the Holmes property. The land was used as a pasture at one time and a significant amount of vegetation had been cleared right up to the streams edge. A 40m section of stream bank parallel with the Highway 401 had severely eroded due to a composition of fine soil, steep bank face and being void of woody vegetation (figure 1). This caused excess sediment to enter the creek, which is known to impede aquatic life. It was evident during the spring freshet that the stream bank was experiencing lateral movement. Visits to the site by the OFAH staff determined that re-grading the slope to 2:1, strengthening the bank with angular stone and planting trees and shrubs would be the best course of action for the creek and its inhabitants. Five LUNKERS were incorporated into the design to provide in stream cover for Atlantic salmon by mimicking overhanging banks (figure 2&3). The direct benefits of the Holmes/Town of Cobourg bank stabilization project reduced the sediment entering the creek, improved and recreated riparian habitat and provided in stream cover for fish. The project was complete mid November when the ground had begun to freeze (figure 4). Therefore, tree and shrub planting will resume in the spring of 2009.
