Habitat Restoration Project 2009

- Duffins Creek: Ajax, Ontario -

Greenwood Conservation Area Bridge Erosion Mitigation and Planting

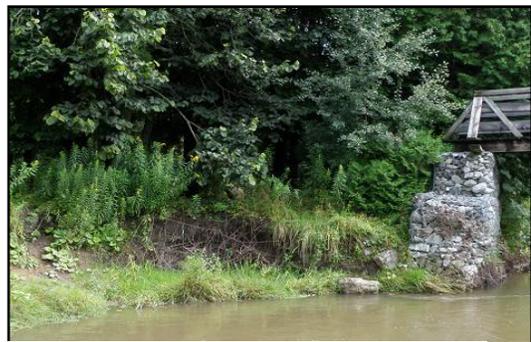
This stream restoration project was at non trial site on the conservation property. It had been used by community members and this activity is what cleared the stream bank of vegetation. A downstream footbridge also had caused erosion along the bank. Water had eroded away the bank behind the bridge supports causing excess sediment to enter the creek, which is known to impede aquatic life (figure 1). By affecting the integrity of the bank, downstream sections were being compromised, which was evident

Figure 1: Evident stream bank erosion.

during the spring freshet. Visits to the site by TRCA staff determined that using root wads, woody debris and shrub planting would be the best course of action for the creek and its inhabitants. Full removal of the bridge and the gabion basket abutments was not possible this year so stabilization and naturalization of the upstream bank was planned as Phase 1. The direct benefits of the Greenwood Conservation Area Bridge Erosion Mitigation project would be to reduce the amount of sediment entering the creek, improve in-stream and riparian habitat, and enhance/increase the riparian cover. On August 20th, 2009, alternation of 30m of stream bank begun by anchoring root wads with soil spikes (figure 2). The project was successfully completed over five August days (187 hours) with help from 42 individuals from the TRCA, the O.F.A.H., the CSSP, the Peterborough MNR Stewardship Rangers and local community volunteers. The project was successfully completed over five August days (187 hours) with help from 42 individuals from the TRCA, the O.F.A.H., the CSSP, the Peterborough MNR Stewardship Rangers and local community volunteers. The riparian area directly behind the newly constructed bank and the area between the logs and root wads down to the toe were planted in the summer with 50 potted 80cm pussy willow shrubs and 52 potted 50cm red osier dogwood shrubs to further stabilize the bank (figure 3).

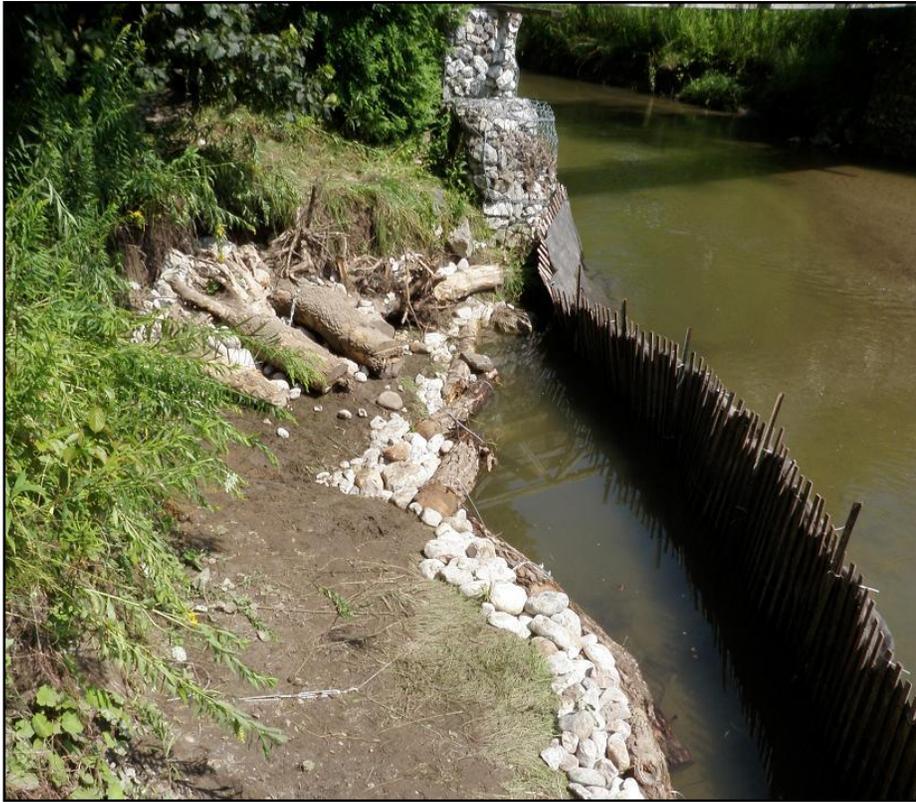
Figure 2: Root wads, logs and river stone in place along the bank to stabilize slope.

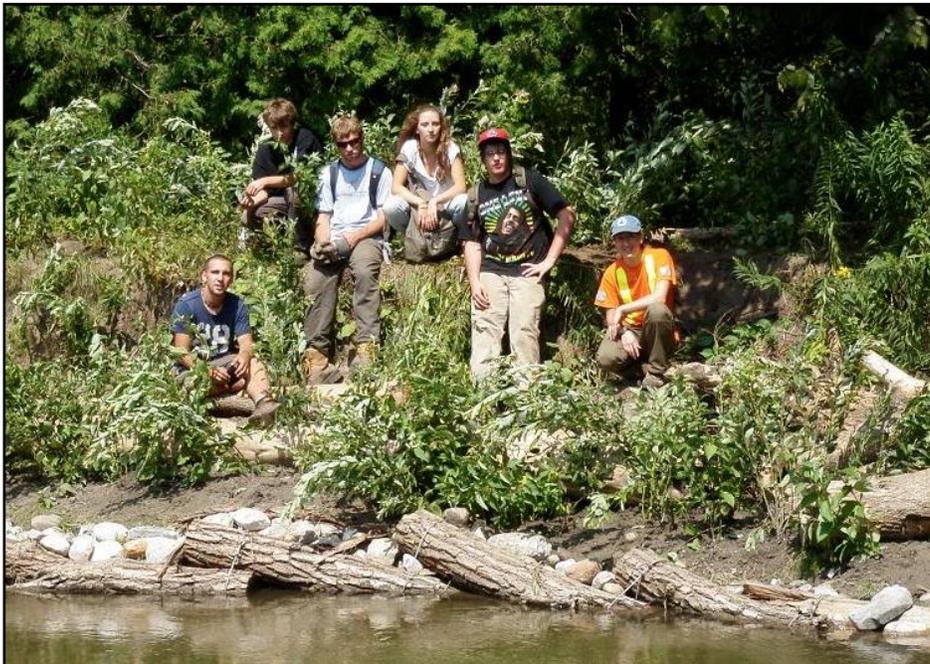
Figure 3: Volunteers after successful completion of the bank mitigation and planting project at Greenwood Conservation Area.
