Habitat Restoration Project 2009

- Cobourg Brook: Cobourg, Ontario -

Holmes Property Bank Stabilization Planting

Date Completed: *May 8, 2009*

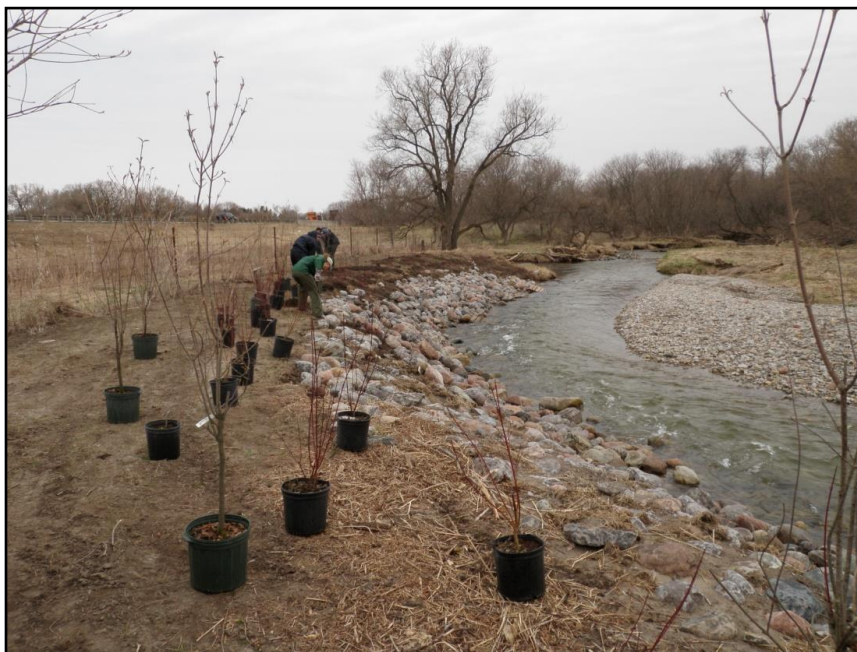
The Holmes property was a site of previous restoration projects. A 40m section of stream bank parallel with the Highway 401 had severely eroded due to a composition of fine soil, steep bank face and being void of woody vegetation (figure 1). This caused excess sediment to enter the creek, which is known to impede aquatic life. In 2008, the OFAH carried out a bank stabilization project, stabilizing the slope and creating fish habitat. Tree and shrub planting of this site was carried out the next spring to increase bank stabilization even more and also to create a nutrient buffer into the stream. On May 8th, 2009, 20 volunteers planted 80 trees and 45 shrubs along the bank where the stabilization project occurred.

Figure 1: Site of previous bank stabilization project in 2008, the stream bank on the Holmes property is now being planted with trees and shrubs in 2009.

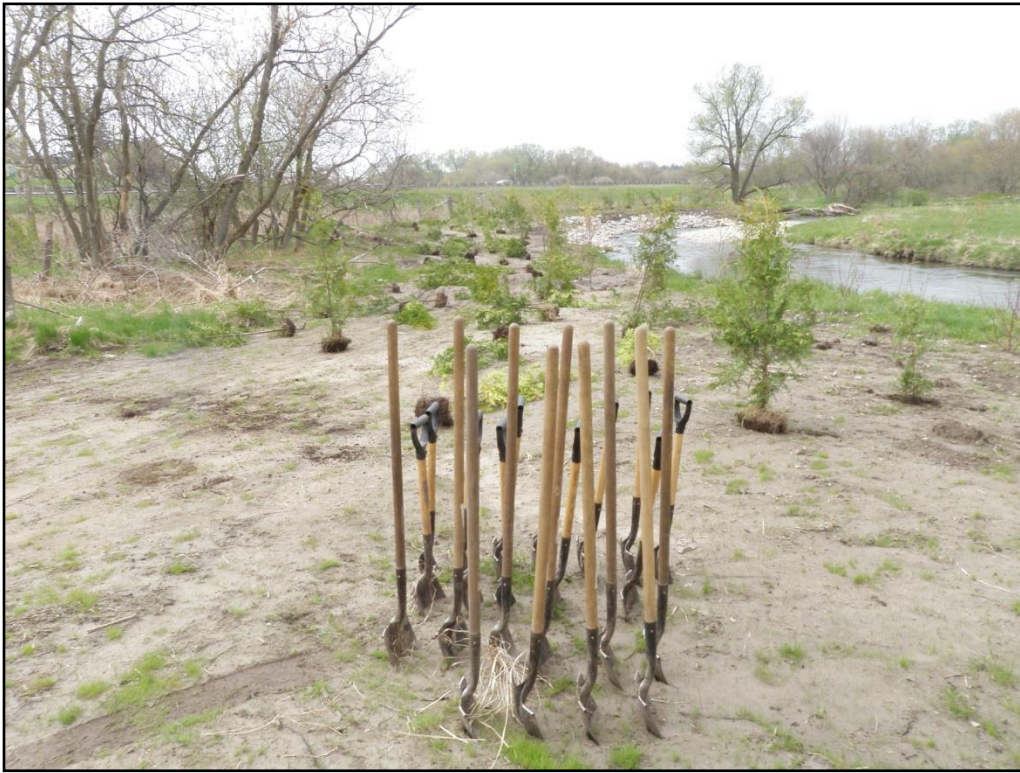
Figure 2: Materials for planting shrubs along the Cobourg Brook bank.

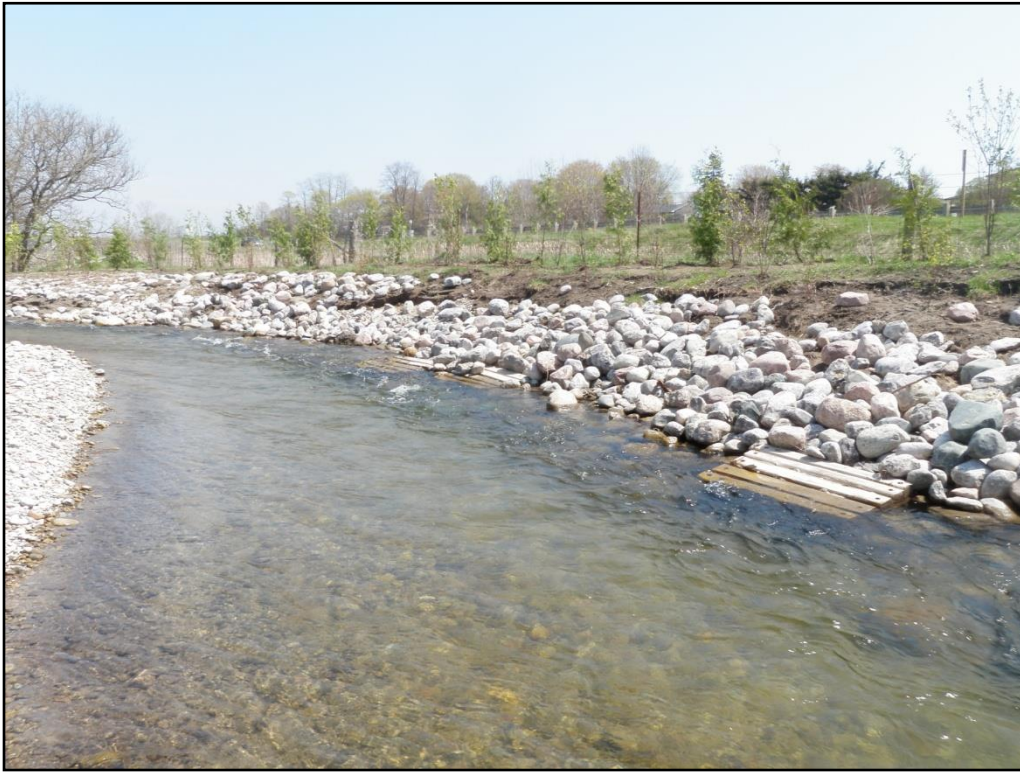
Figure 3: Completed tree and shrub planting along the bank stabilization project on the Holmes property.
