## Habitat Restoration Project 2010

- Duffins Creek: Ajax, Ontario -

### Greenwood Conservation Area Root Wad Placement Bank Stabilization

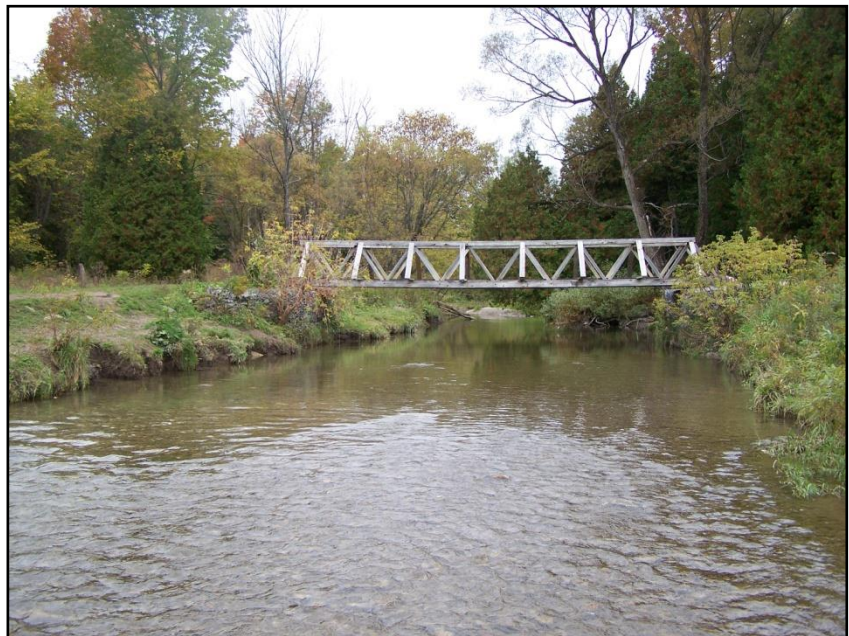
**Figure 1:** Before stabilization project began at Greenwood Conservation Area in Pickering, ON.

Greenwood Conservation Area in Ajax, Ontario is a highly used recreation facility. Within the conservation area, Duffins Creek has areas of bank instability and erosion (figure 1). One such area was of concern, with a foot bridge in need of replacement, and the stream banks in need of root wad installation for stability. On September 15<sup>th</sup>, the root wad installation project was completed with the help of 8 volunteers from the Toronto and Region Conservation Authority (TRCA) and the OFAH. A new foot bridge was installed to carry pedestrians as well as heavy machinery which was need to complete the bank stabilization project (figure 2), and the old foot bridge was dismantled. Silt fencing was placed within the water to catch any sediment that may be passed downstream before any work began. The root wad and log placement created stability for the soil along the banks and staff members hope it will decrease erosion. Straw fabric was placed along both sides of the stream on the banks to further prevent siltation into the water.

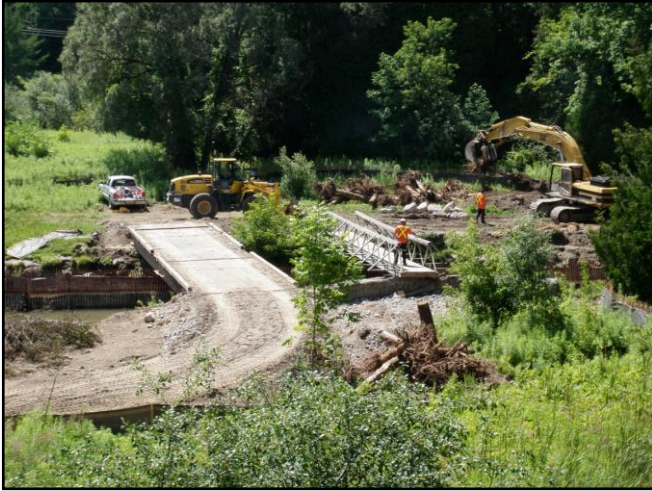
**Figure 2:** Building of new bridge and then dismantling of the old bridge will begin.

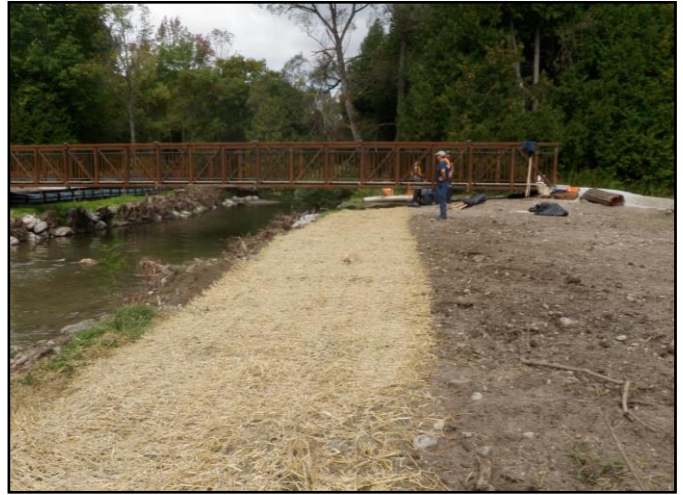
**Figure 3:** New bridge built and root wad and straw in place along banks of Duffins Creek.

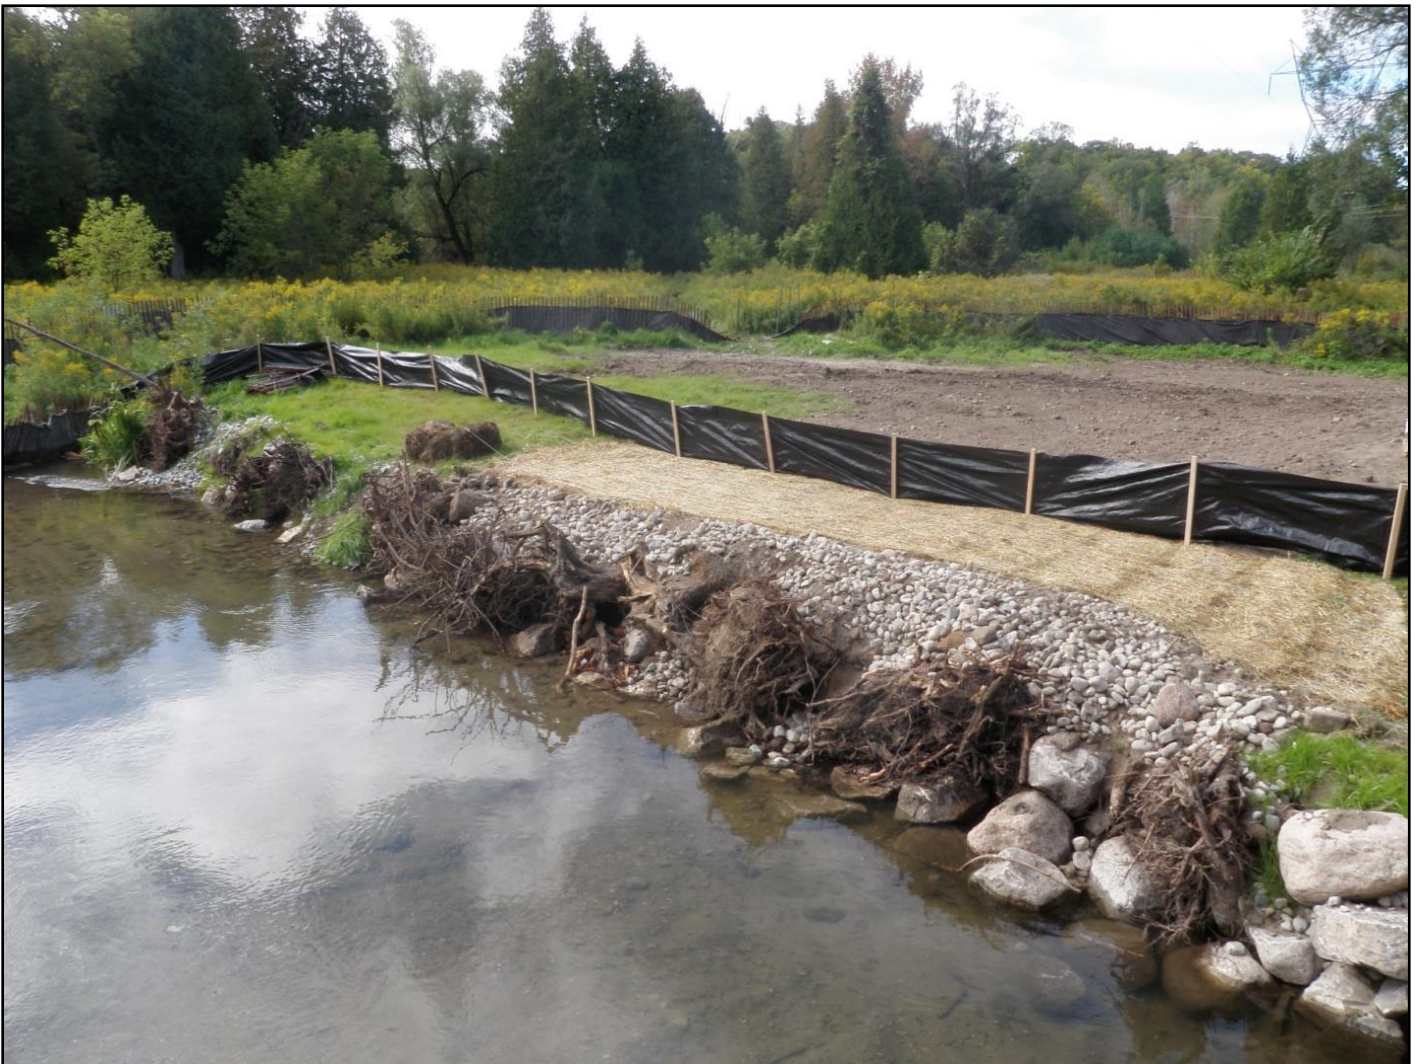
**Figure 4:** Completed root wad and bank stabilization project at Greenwood Conservation Area along Duffins Creek.
