## Habitat Restoration Project 2010

- Cobourg Brook: Cobourg, Ontario -

### Hie Pond-to-stream Interface Reconstruction

Date Completed: *September 8, 2010*

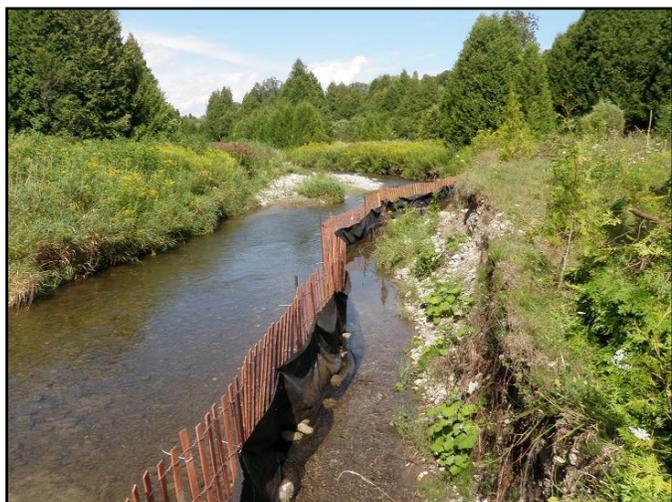
Figure 1: Eroded bank on Hie Property.

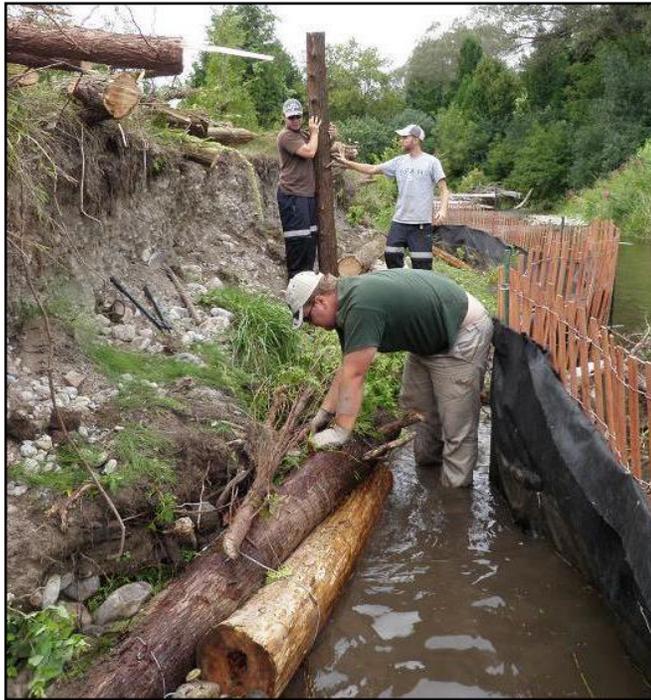
Figure 2: Installing logs and root wads to hold the bank in place.

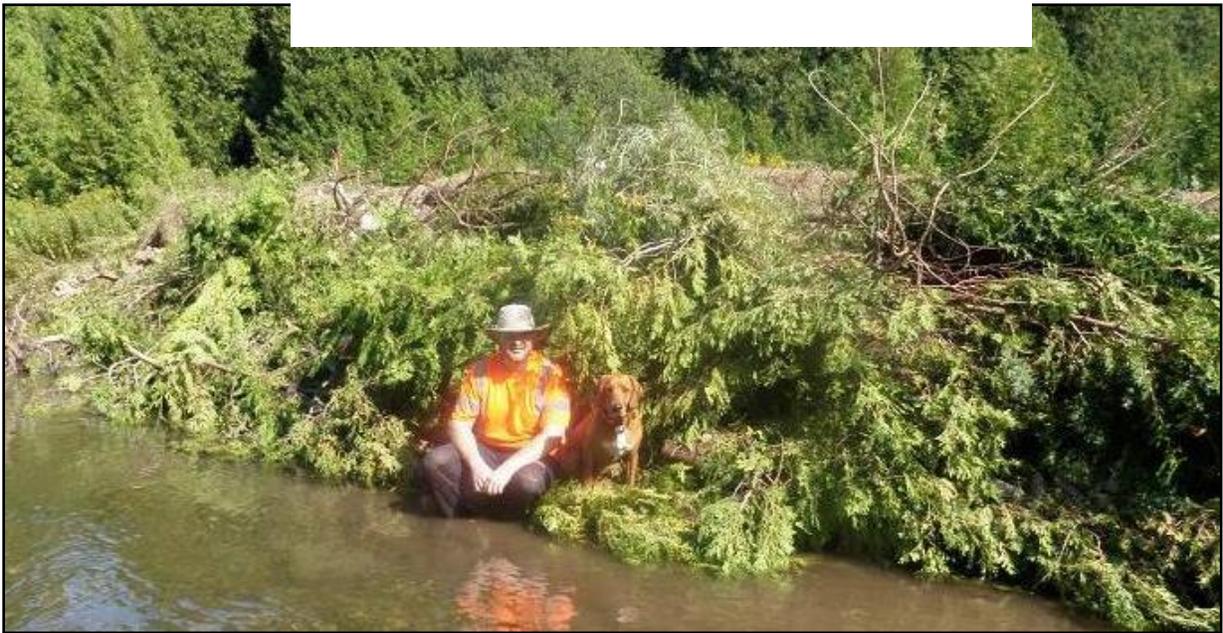
Figure 3: OFAH staff member and dog sit in front of completed pond to stream interface reconstruction project.

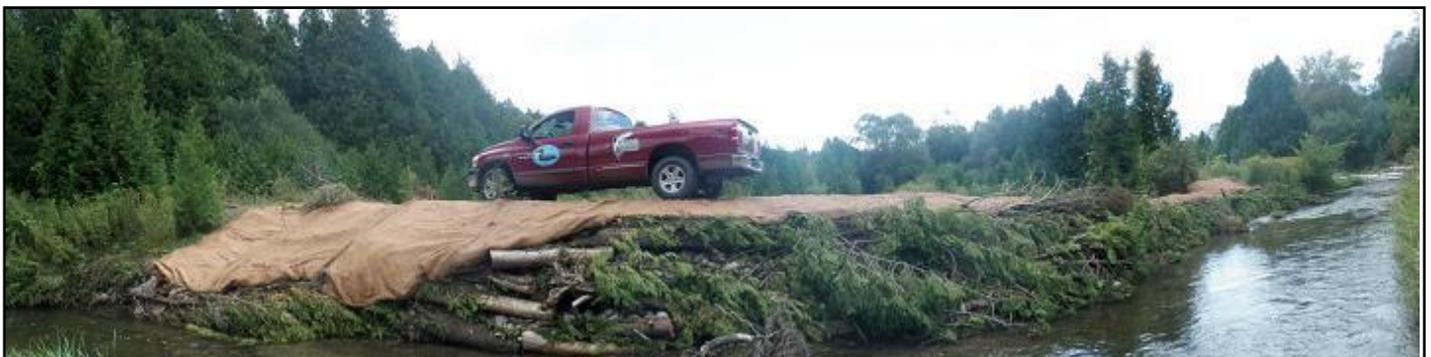
Figure 4: Completed project - 60m of bank stabilization.
