Habitat Restoration Project 2011 - Duffins Creek: Pickering, Ontario -

Greenwood Conservation Area Rodar Park Log Revetment

Date Completed: *August 10, 2011*

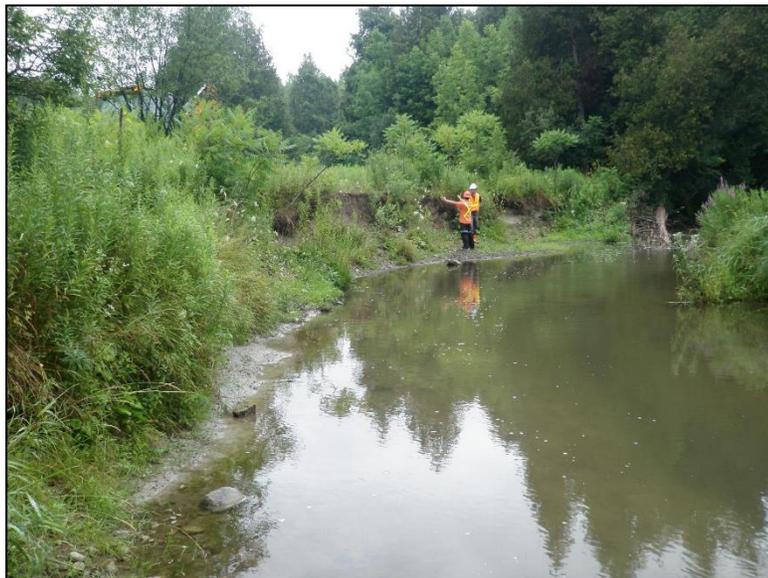
Figure 1: Revetment site before restoration with eroded banks.

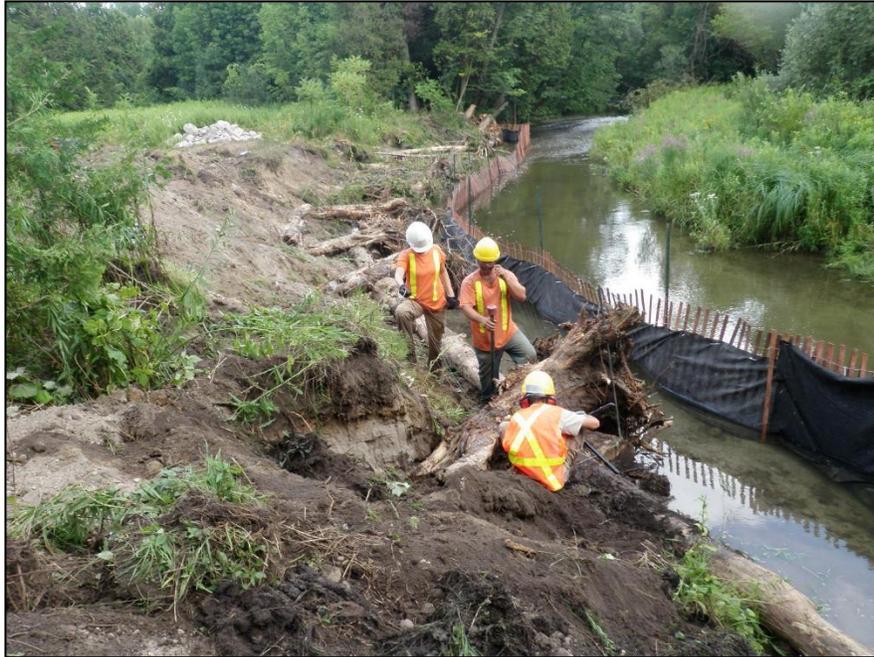
Figure 2: OFAH and TRCA crews anchoring root wads along the stream bank.

This summer, the Lake Ontario Atlantic Salmon Restoration Program partnered with the Toronto and Region Conservation Authority (TRCA) to undertake a large scale bank stabilization project along Duffins Creek in the Greenwood Conservation Area, Rodar Park. One Georgian College co-op student helped for 26.5 hours alongside OFAH, TRCA and Community Stream Steward Program staff to complete this project. Staff first installed a sediment fence to stop any erosion caused by working in the water, preventing any harmful alterations to fish habitat. The eroded stream bank was built back up with large woody material including root wads (stump with roots attached) anchored to the bank with aircraft cable (revetment) and round river stone to fill in the smaller spaces. The revetment technique was used because it is a soft (rather than all rock) approach to bank stabilization, the root wads mimic natural root structures found in less disturbed areas. Also over time they allow the stream bank to trap sediment during high water rain events and build the bank up again. The work took place from August 4 to August 10, 2011 and the sediment fence was left in for another month to collect sediment as the newly restored bank settled. This project improved Atlantic Salmon habitat by providing shade under overhanging root wads, stabilizing the stream bank to reduce erosion and

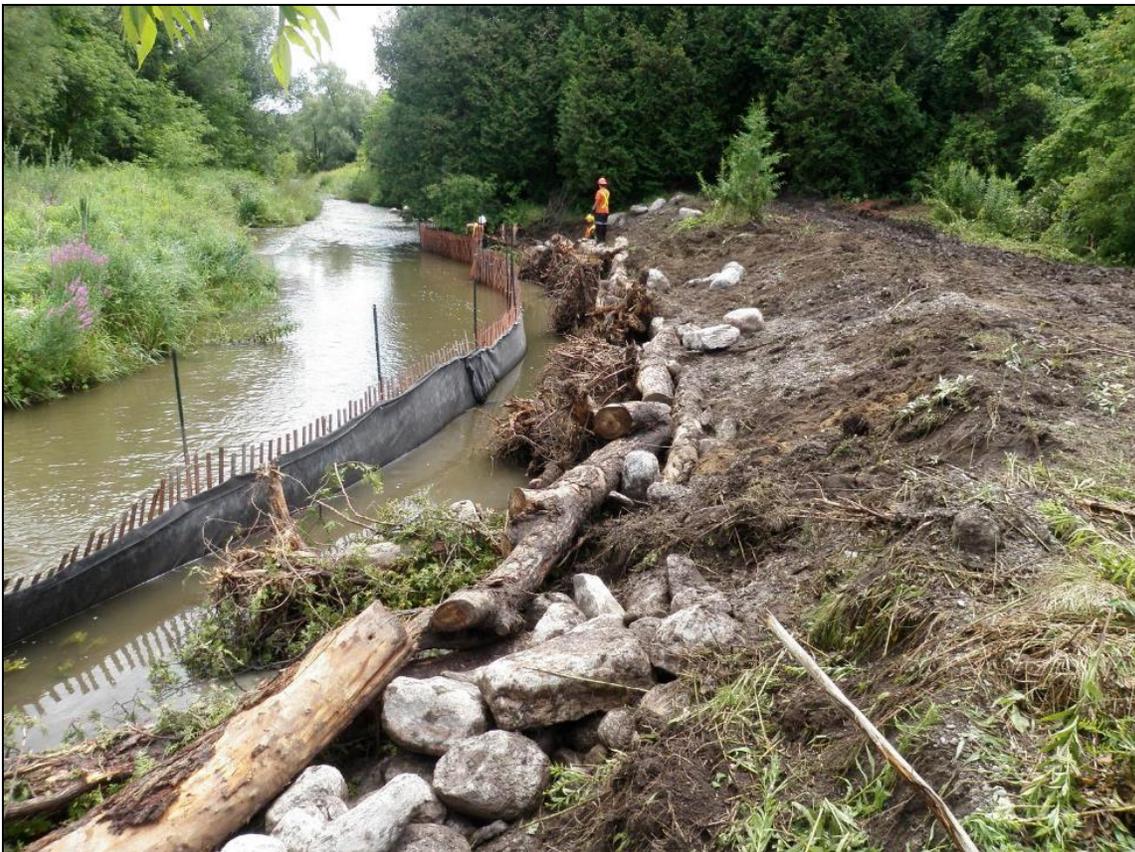
Figure 3: Revetment site downstream photo nearly completed.
