Habitat Restoration Project 2014  
- Duffins Creek: Ajax, Ontario -

### Brock Lands Decommissioned Pond Live Willow Shrub Staking

Habitat Project Lead: *Ontario Federation of Anglers and Hunters*

Date Completed: *November 27, 2014*

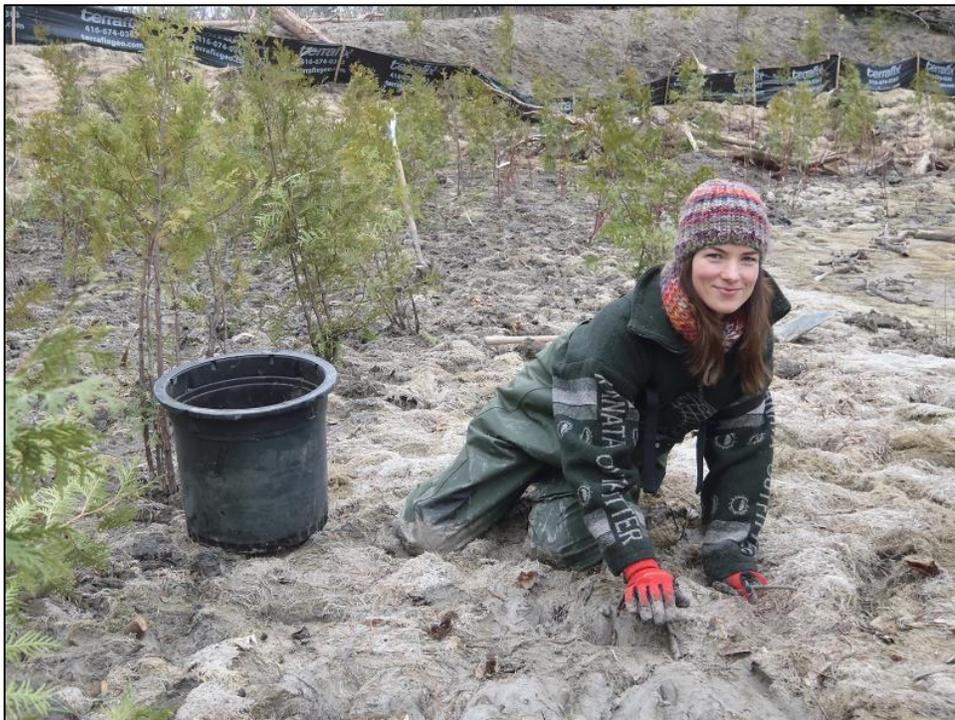
Figure 1: Live willow shrub staking in the drained pond.

The project is located in Pickering, Ontario on the Greenwood Conservation Lands, Brock North portion. This is the site of a previous pond decommissioning, for this we used a planting technique of inserting live willow shrub stakes (stem cuttings) into a half metre of the bypass channel shoreline. Willow shrubs can be cut down to the base, leaving the roots, in the fall once they have gone dormant and dropped their leaves. The shrub stems are then cut into 30-60cm long stakes, flat at one end and angled at 45 degrees at the other. These stakes are inserted or pounded into the ground before the frost and will start to grow in the spring. Planted vegetation absorbs water at periods of high flow and releases it slowly during dry periods, which maintains a longer period of base flow water conditions needed for fish to function and survive in a stream.

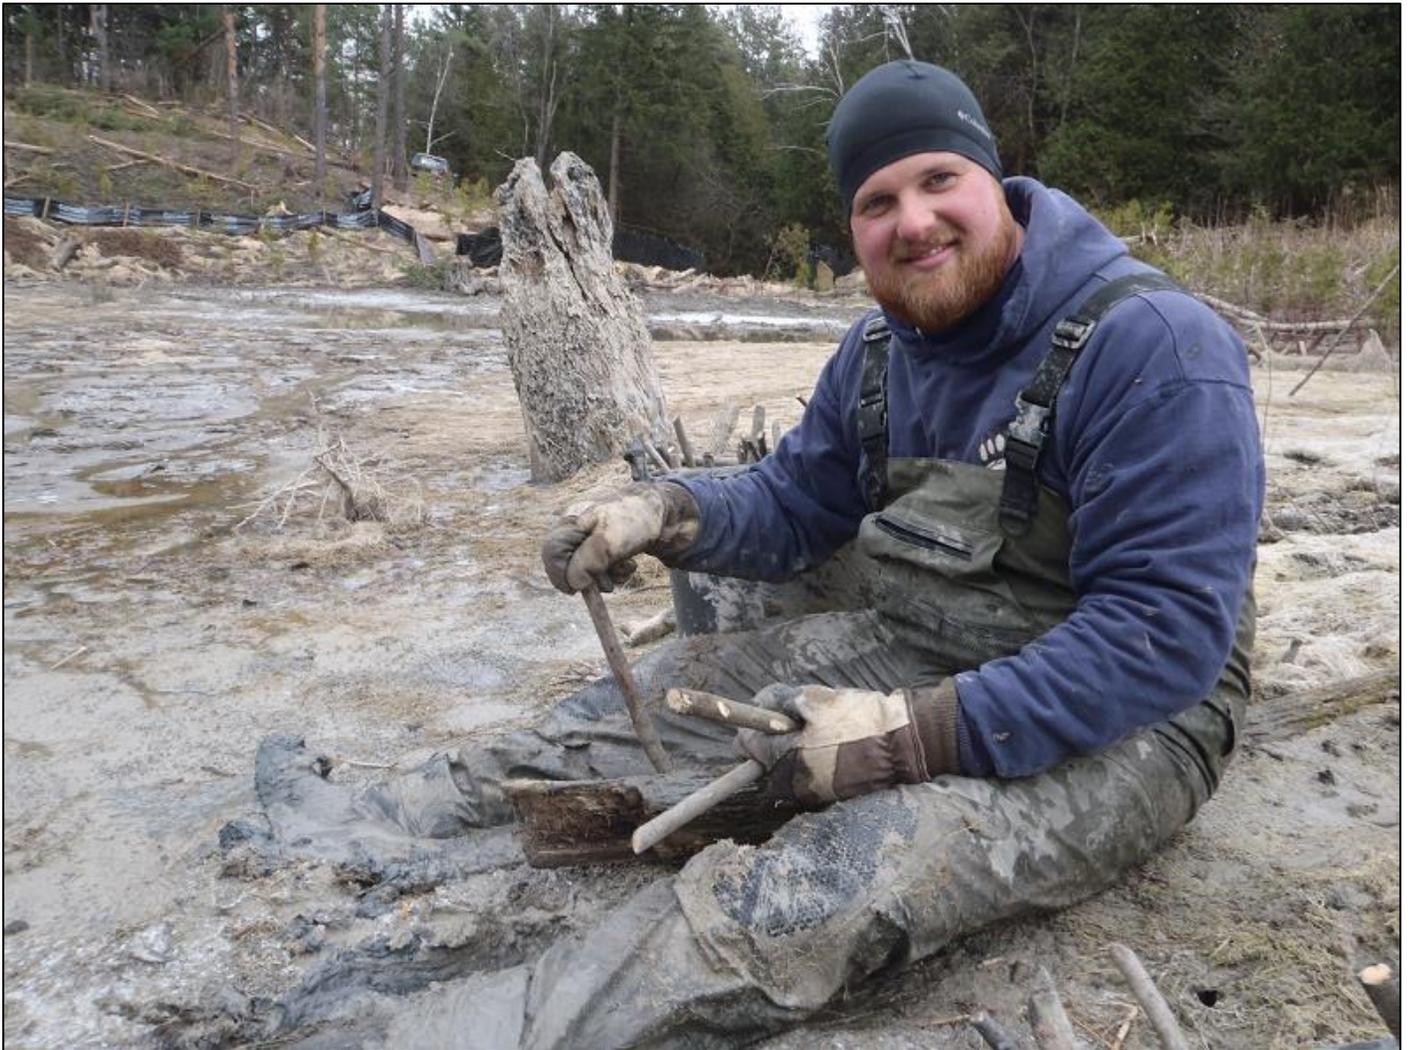
Figure 2: OFAH Atlantic Salmon Habitat Technologist installing willow stakes into the soft ground.

A Fleming College volunteer, OFAH co-op student and two staff installed 7,775 live willow shrub stakes at the edge of the creek in 195m<sup>2</sup> of the upstream portion of the new channel. Over the two days (November 26 and 27, 2014), volunteers and staff inserted the stakes into the wet ground that remained after draining the pond. Besides stabilizing the stream bank, we hope that the large quantity of (fast-growing) live willow shrub stakes will also slow the spread of invasive Phragmites Reed. Phragmites is an aggressive plant that spreads quickly and out-competes native species for water and nutrients.

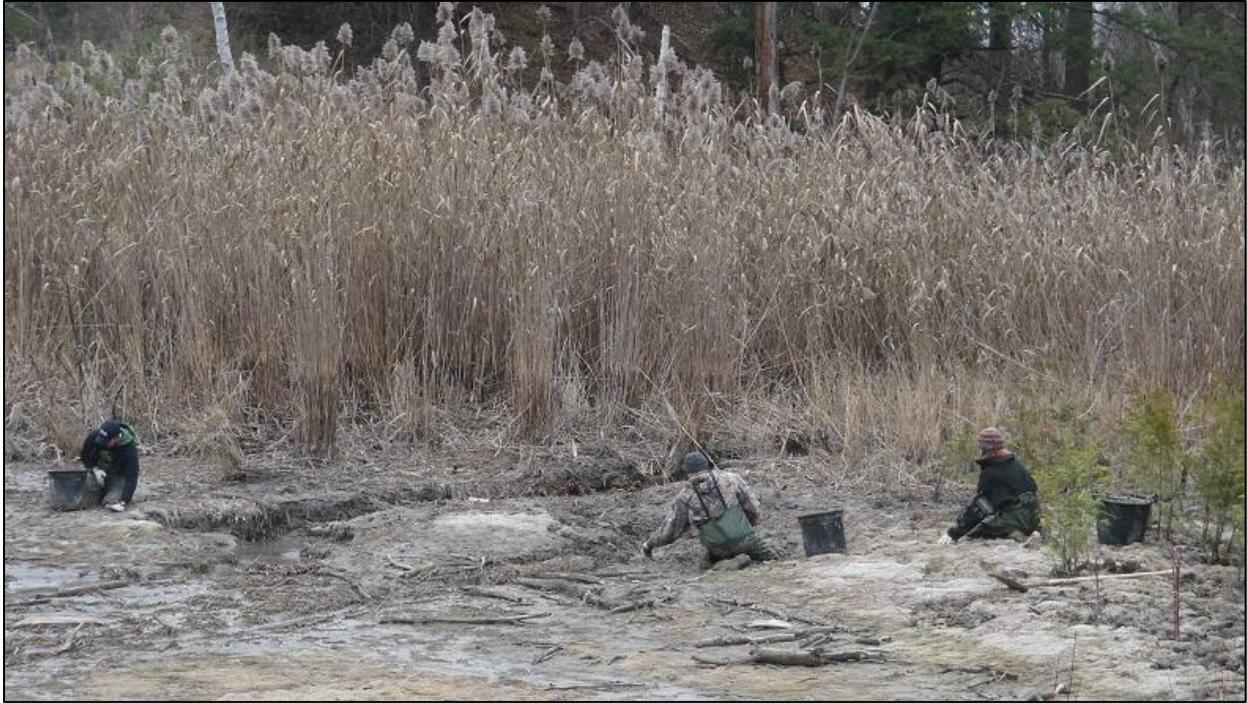
Figure 3: Live willow shrub staking around the stream channel. The tall reed dominating the area behind the volunteers is invasive Phragmites. We are trying to slow the movement of it into the drained pond.

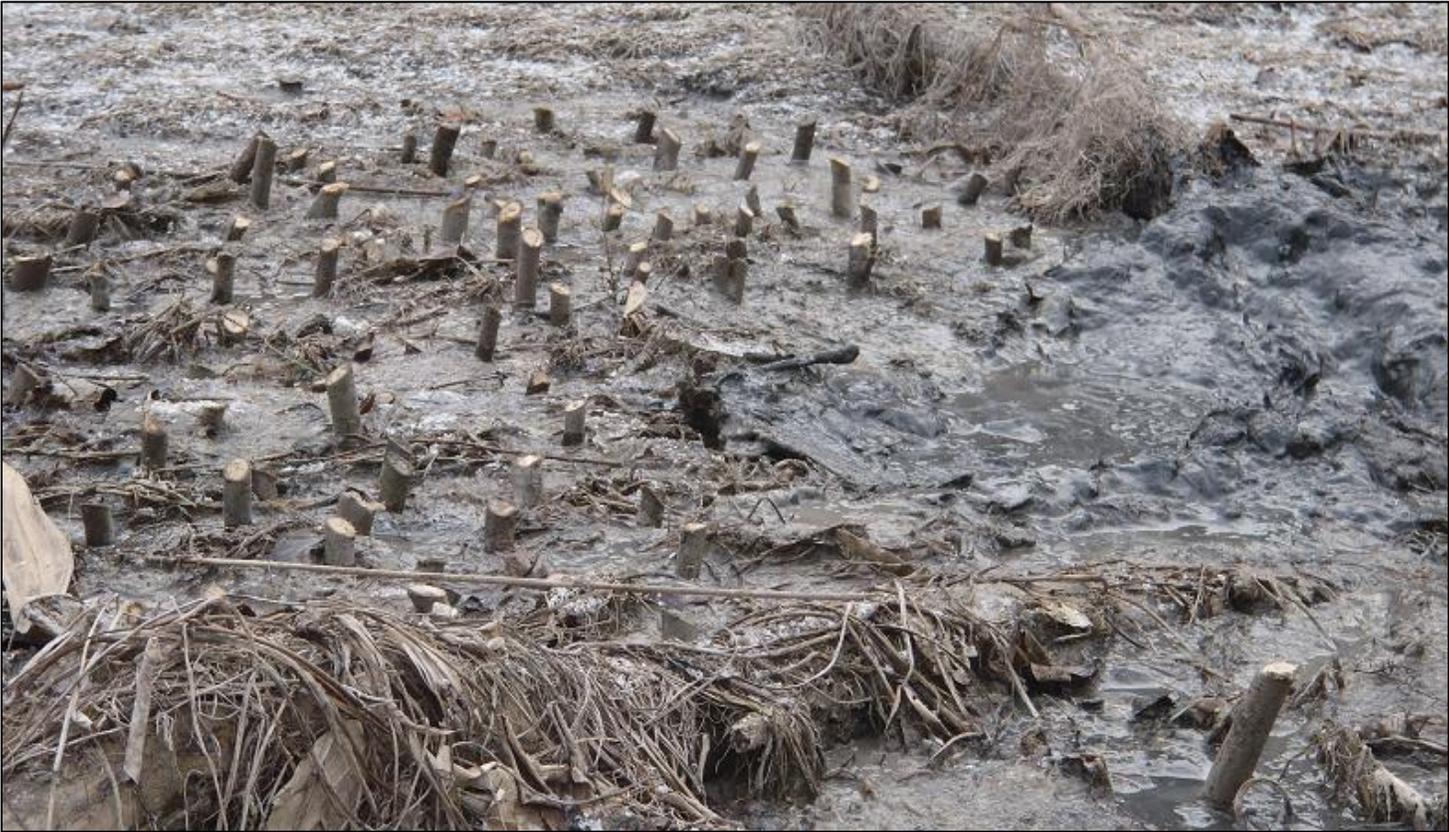
Figure 4: Live willow shrub stakes installed in the ground.
