Habitat Restoration Project 2015

- Duffins Creek: Ajax, Ontario -

Annie Crescent Park Bank Stabilization

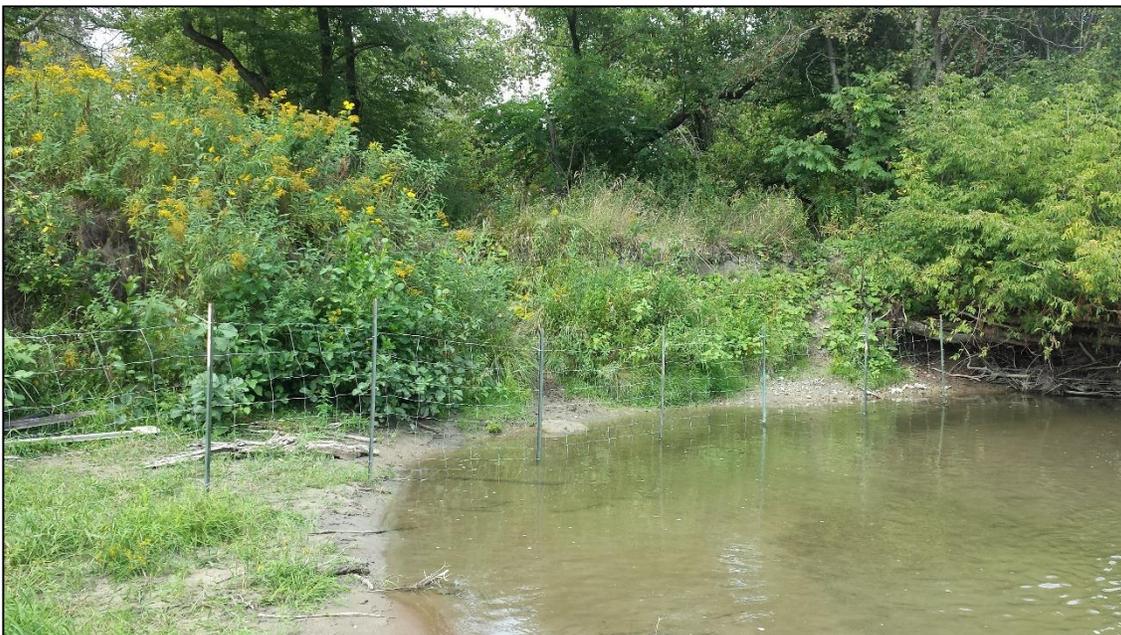
Figure 1: Annie Crescent Park stream bank before restoration, sediment fencing install has started.

In early September, the Lake Ontario Atlantic Salmon Restoration Program partnered with the Toronto and Region Conservation Authority (TRCA), Trout Unlimited Canada (TUC) and Town of Ajax to undertake two activities along Duffins Creek in Annie Crescent Park, Ajax. The first project was a bank stabilization project that started out with TRCA staff installing a sediment fence to stop any additional erosion caused by working in the water, preventing any harmful alterations to existing fish habitat. As the park trail was too close to the creek's edge and causing problems with erosion of the streambank (a lack of space for trees to grow), the Town of Ajax had the trail moved further away while construction equipment was onsite completing the restoration work.

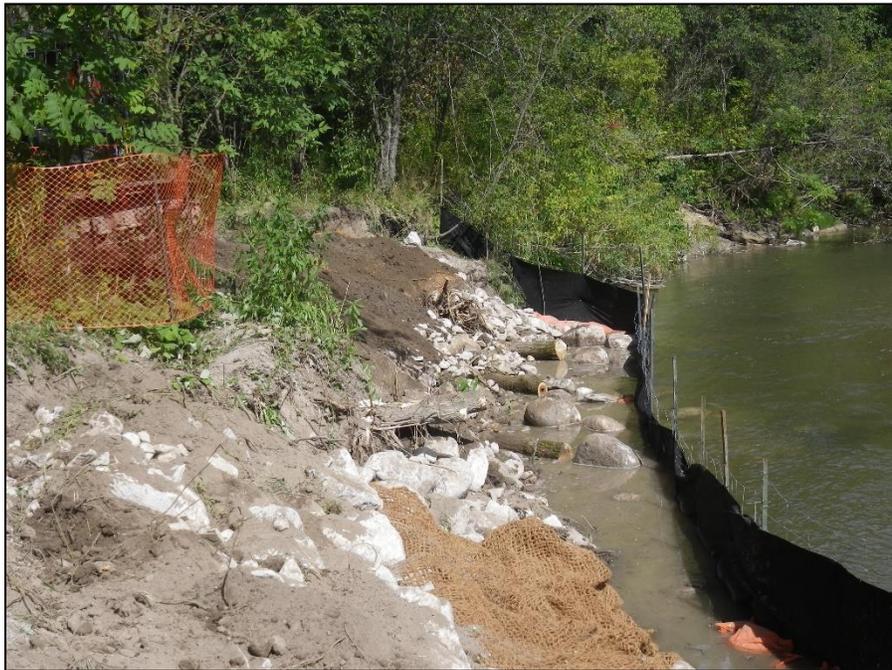
Figure 2: Bank stabilization during construction.

The eroded stream bank was reconstructed with a more gradual slope and large woody material, including root wads (stump with roots attached), were anchored to the bank with aircraft cable. The root wads mimic natural root structures found in less disturbed areas. Also, over time they allow the stream bank to trap sediment during high water rain events and build the bank up again. The stream bank was finished off with round river stone to fill in the smaller spaces. The work took place from September 1 to September 18, 2015 and the sediment fence was left in for another month to collect sediment as the newly restored bank settled. This project improved Atlantic Salmon habitat by providing shade under the overhanging root wads, stabilizing the stream bank to reduce erosion and visually illustrate the importance of habitat restoration to community members that bike and hike these public lands.

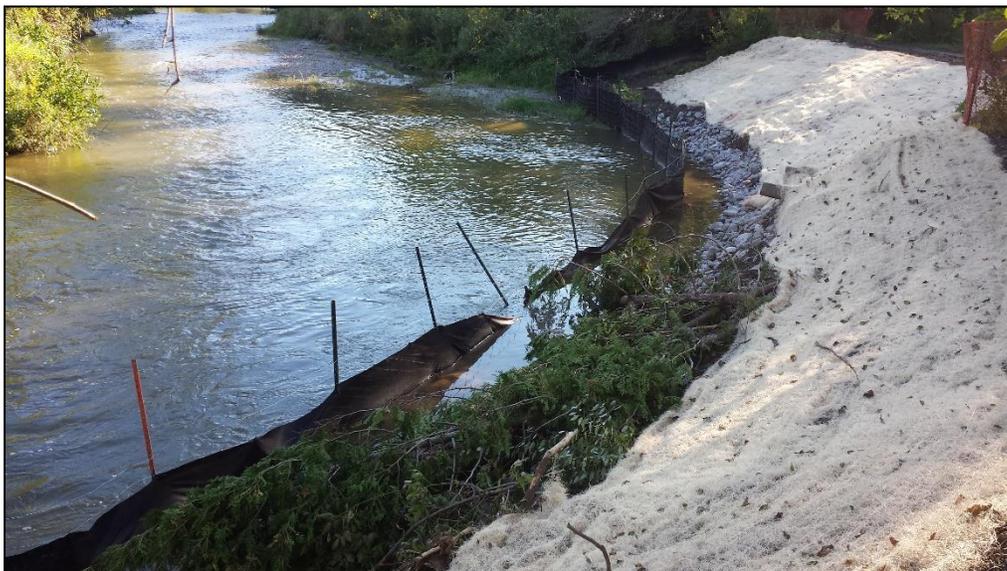
Figure 3: Bank stabilization after construction.
