Habitat Restoration Project 2008

- Duffins Creek: Pickering, Ontario -

Cherry Downs Golf Course Barrier Removal

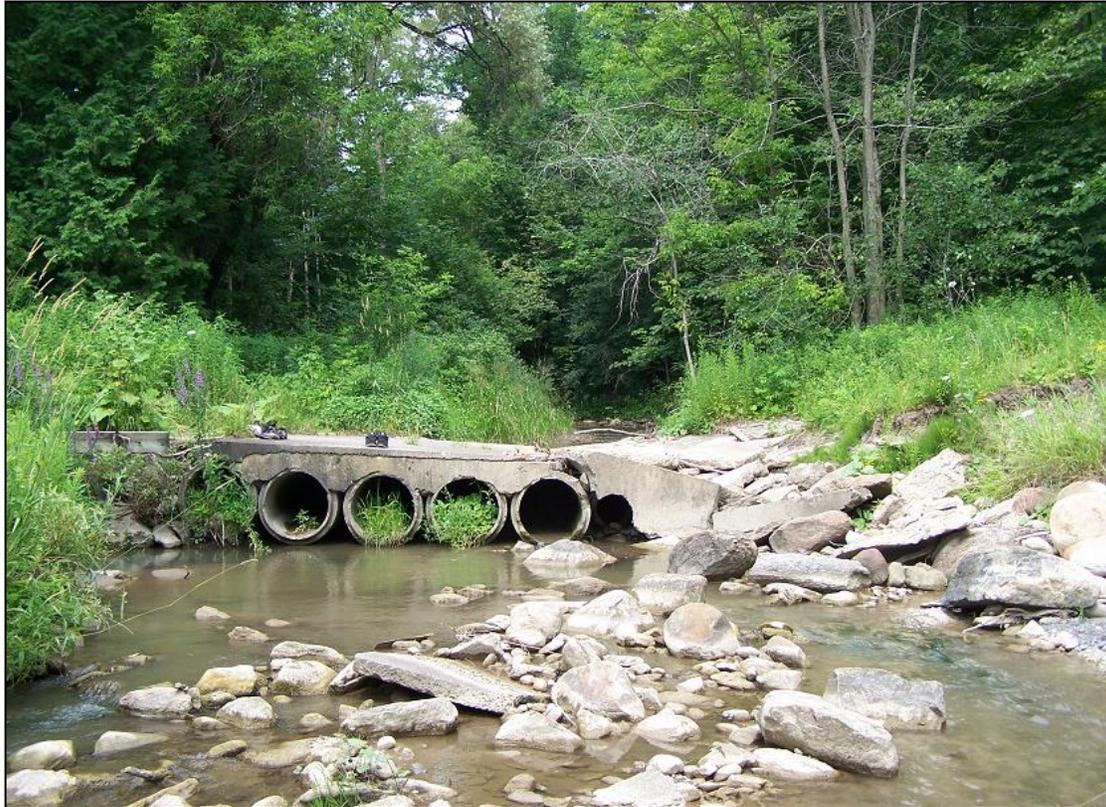
Figure 1: Cement bridge located on Cherry Downs Golf Course which was restricted flow of river and impeding fish species from travelling up and down the stream.

This project involves the removal of a 10m by 6m cement bridge with 6 culverts (1m diameter) that were blocking the water flow and movement of fish upstream. The Cherry Downs Golf and Country Club has not used the large cement bridge for 20 plus years due to the installation of an arch eagle bridge downstream for golfers to cross the creek. The bridge-blocked water at base flows, dropping water levels downstream and at peak flow blew out the bank to approximately 12m wide (figure 1). The benefits of the barrier removal project were such that it would decrease sediment buildup, allow spawning Atlantic salmon to migrate upstream and forage fish populations to mix. The focus of much of the project was the removal of a failed/poorly placed bridge and naturalizing the stream bank and surrounding riparian zone. On September 10th with the installation of a 12m long snow fence temporarily staked into the creek bed with the inner portion being covered with a synthetic filter cloth for silt capture. Removal of the failed cement bridge and reconstruction of the stream bank took two days. Crews from the OFAH and TRCA accomplished this project using a rented excavator owned and operated by a local contractor (3 days) and with a large Kubota tractor with a dump trailer donated and operated by the golf course (2 days). Once all the cement was removed from the stream and riparian area the bank slope was re-graded to a 2:1 ratio. One load of river round stone was then placed along the bank and into the water, immediately along the creek edge to recreate a stable shoreline (figure 2).

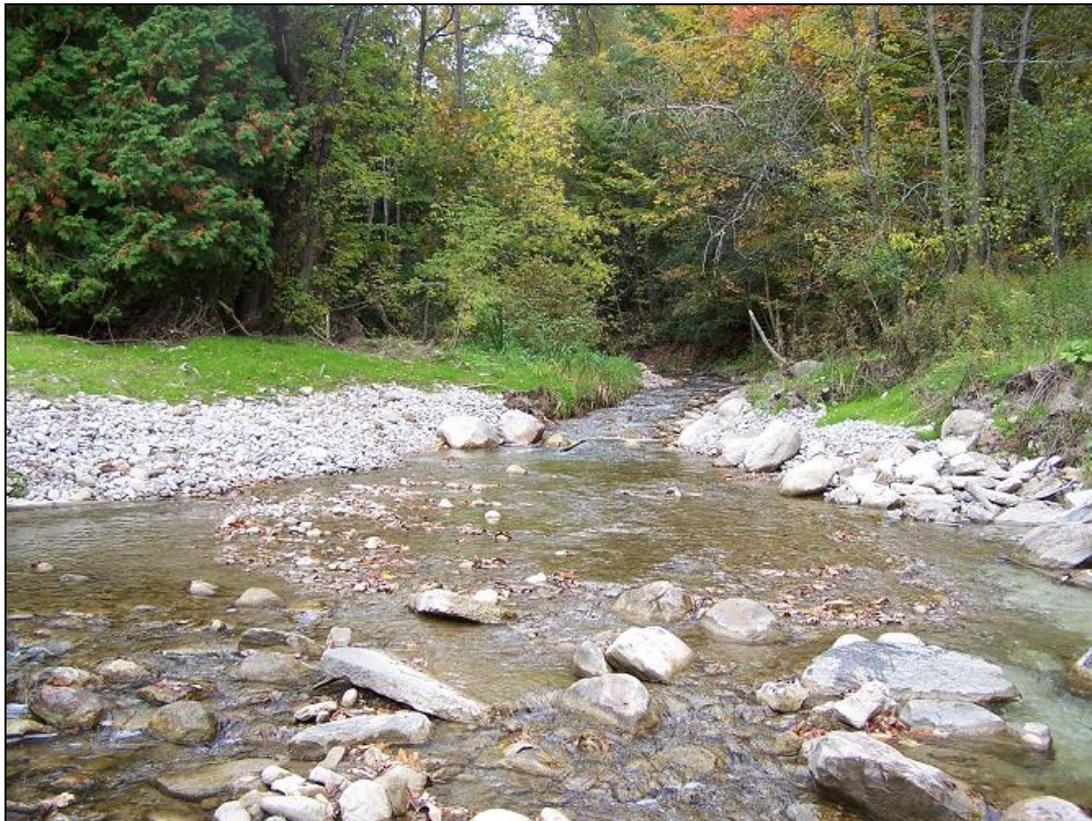
Figure 2: Stream after the cement bridge was removed and river stone placed along the shoreline.
