## Habitat Restoration Project 2009

- Duffins Creek: Pickering, Ontario -

### Bushwood Golf Course Bank Stabilization Planting

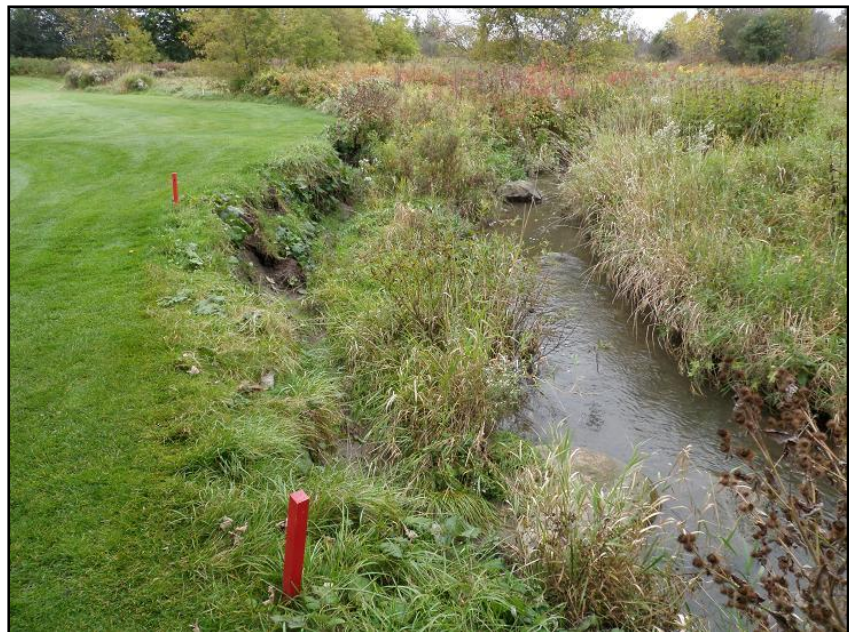
The Bushwood Golf Course Bank Stabilization Planting project was located upstream of the 'Shrub Planting Project' at the golf cart bridge on the Transport Canada Pickering Lands property rented to Bushwood Golf Course. The planting site is at the 12<sup>th</sup> hole beside the green where the stream enters the property at the most northern end (figure 1). The stream bank at this section had a severe erosion problem that was removing land close to the green and bank slumping was occurring. This project enhanced the riparian cover, improved water temperatures, minimized erosion and sediment deposition and aided in nutrient uptake.

Figure 1: Stream bank of Duffins Creek on Bushwood Golf course, eroded and washing away into stream (before planting).

Planting shrubs along the toe of the bank where the slumping was occurring will allow the bank to re-stabilize. On December 1<sup>st</sup>, 5 volunteers (15 hours) from the Lake Ontario Atlantic Salmon Restoration Program planted 96 shrubs (figure 2). Potted red osier dogwood (50), nannyberry (25) and fragrant sumac (20) were planted along the stream bank to stabilize the outside creek bend. The total planted area for this project was 120m<sup>2</sup> and the length of Duffins Creek enhanced was 40m (figure 3).

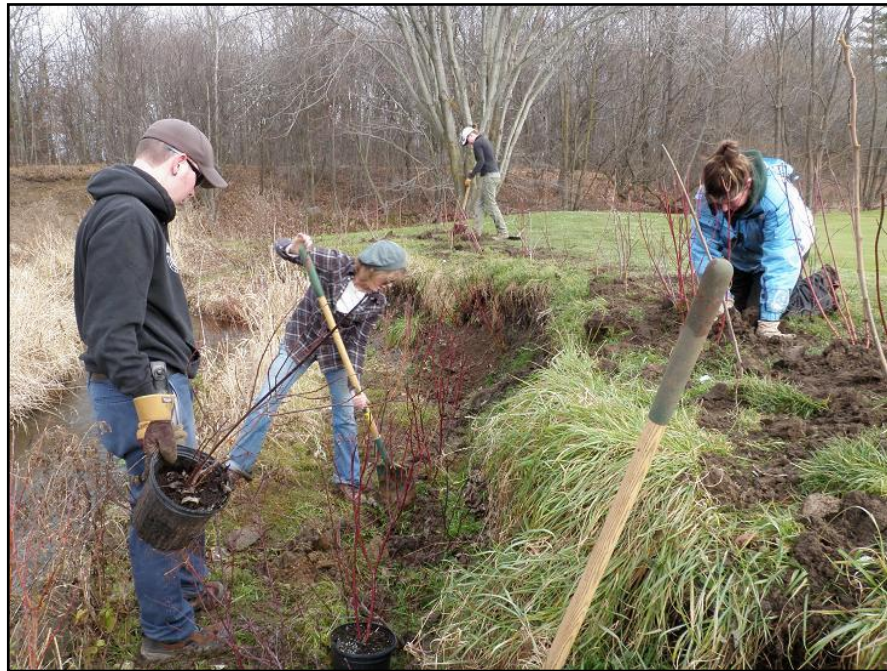
Figure 2: OFAH staff planting dogwood, nannyberry and sumac along Duffins Creek.

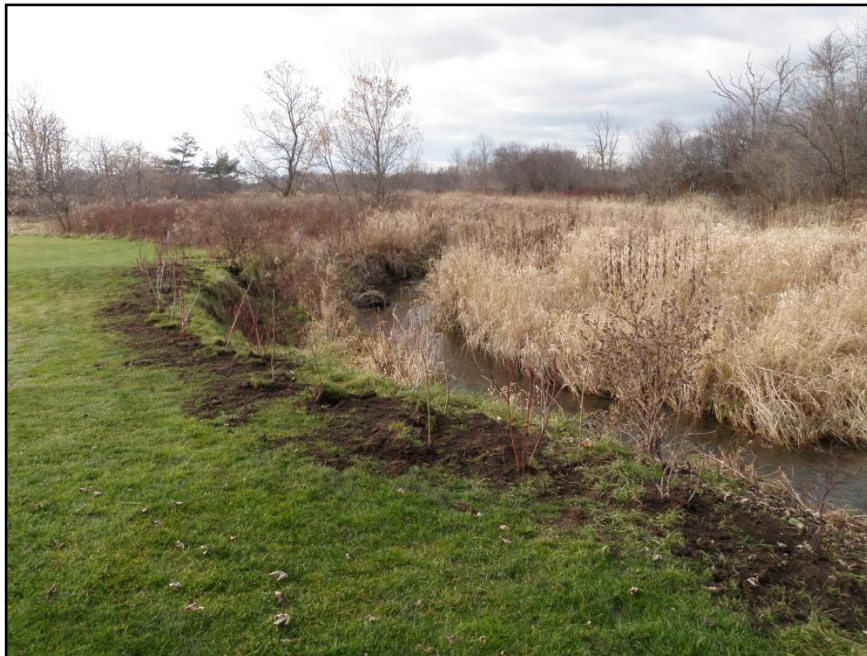
Figure 3: Completed planting at Bushwood Golf Course on December 1<sup>st</sup>, 2009.
