Habitat Restoration Project 2010

- Duffins Creek: Ajax, Ontario -

Greenwood Conservation Area Hydro Corridor Boulder Placement

Date Completed: *September 15, 2010*

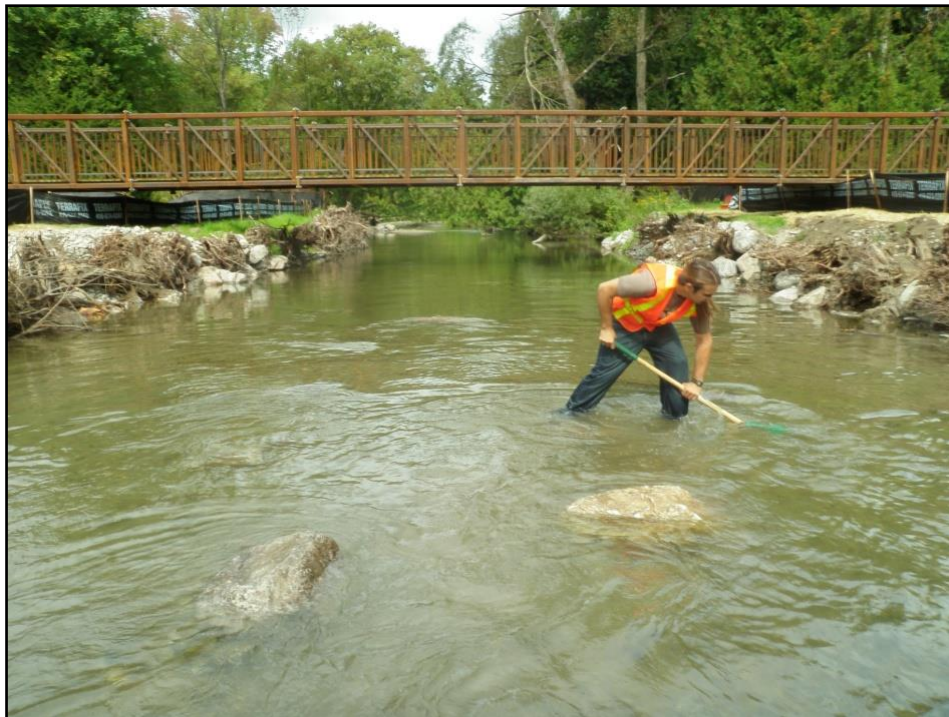
Figure 1: OFAH crew placing the boulders in the stream.

This project was completed in occurrence with the Greenwood Conservation Area Hydro Corridor Root Wad Placement and Bank Stabilization Project. The bank stabilization project enhanced bank stability at the hydro corridor site, and the next step was to improve the habitat for fish species. Adding boulders into the water increases turbidity and oxygen movement in the stream. It also acts as a resting spot for Atlantic salmon on their migration upstream and a hiding spot for juvenile fish. On September 15th, 2010, Toronto and Region Conservation Authority staff and OFAH staff completed the boulder placement within Duffins Creek where the root wad and bank stability project took place, as well as underneath the new bridge at the hydro corridor site (figures 1, 2 & 3).

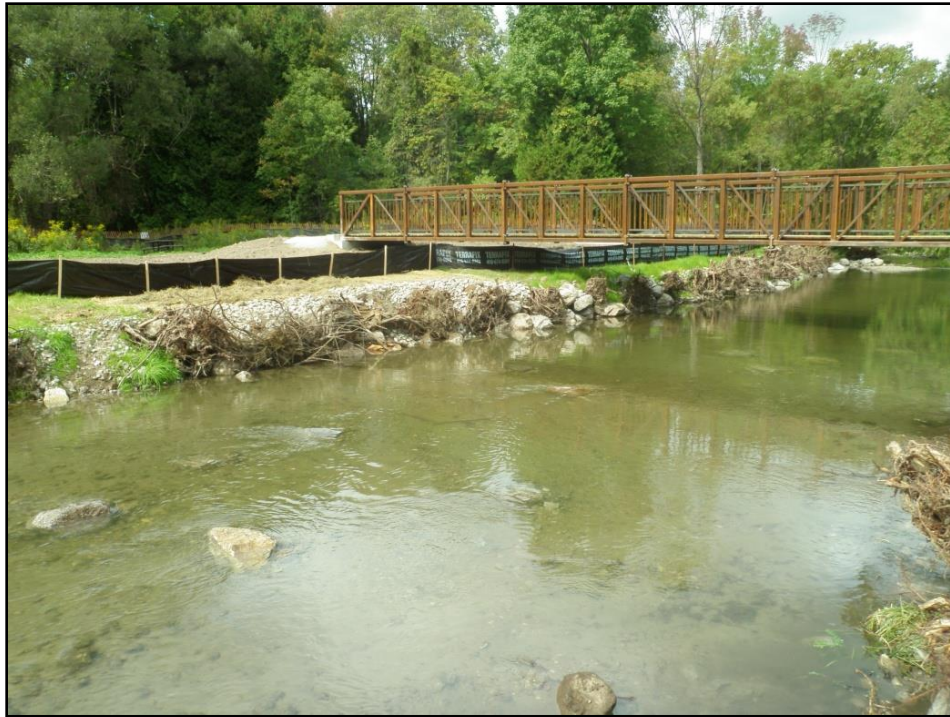
Figure 2: Finished boulder placement.

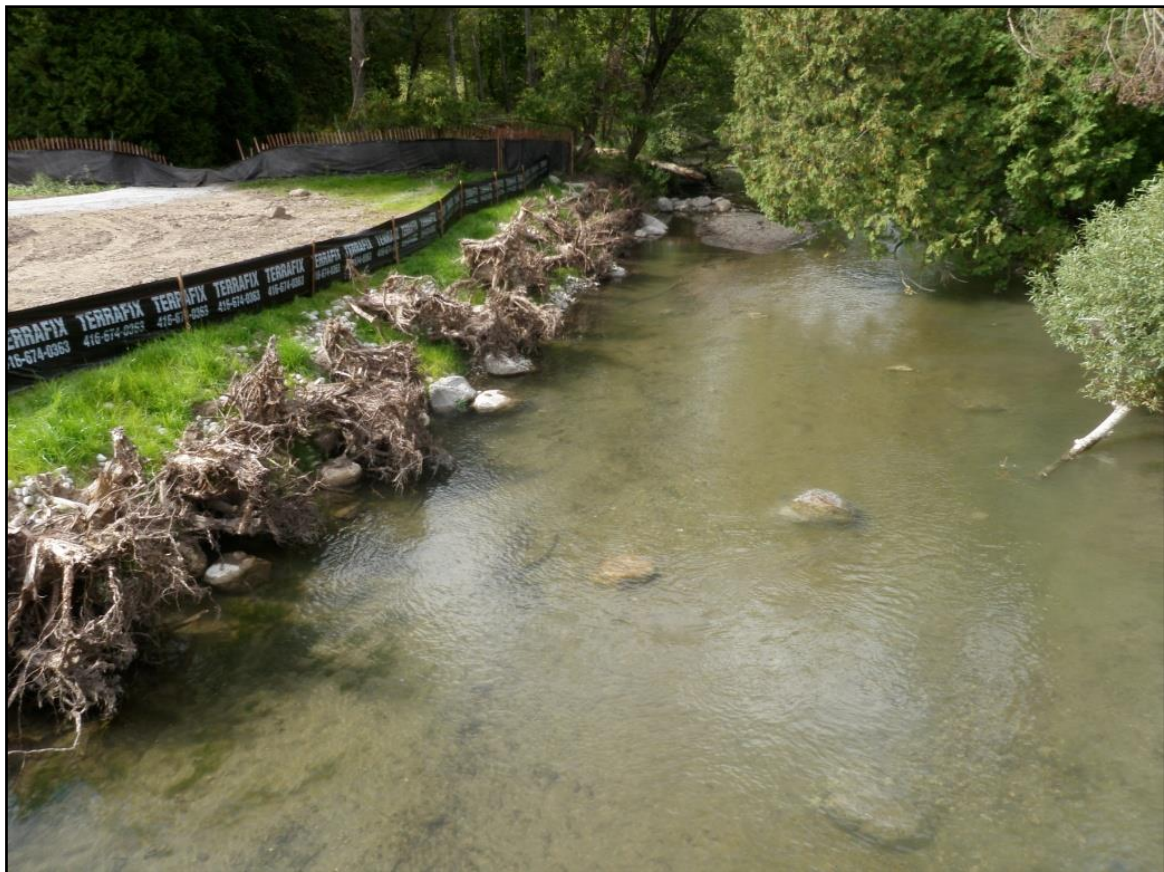
Figure 3: Boulders placed along the creek bottom in pods (groups of 3-5).
